Access Compliance Report Public Rights-of-Way (Curb Ramps)

Intersection ID: 50320 Main Street: BRYN_ATHYN_CT Cross Street: CINDY_LN Location: SW

ADA ID: FC9071F89720 Ramp Type: Directional1 Initial Pass/Fail: Fail Overall Compliance: No Severity Score: 12.5

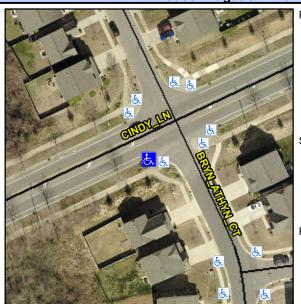
Possible Solutions:	Compl	iance	Description
Remove & Replace Entire Ramp.	N/A	Ramı	c Length (in)
·	Yes	Ramı	o Width (in)
	No	Ramp	o Slope (%)
	Yes	Ramp	XSlope (%)
	N/A	Flare	Type LT
	N/A	Flare	Slope LT (%)
Surveyor Notes:	N/A	Flare	Traversable LT?
N/A	N/A	Land	ing Length (in)
	N/A	Land	ing Width (in)
	N/A	Land	ing Slope (%)
	N/A	Land	ing X Slope (%)
PROW/ADA:	N/A	Land	ing Curb? (Y/N)
R304.2.2	N/A	Share	ed Landing?
	N/A	Gutte	er Ponding?
	N/A	Gutte	er Lip Ht (in)
	N/A	Paint	ed X Walk1?
		X Wa	lk 1 Direction
		X Wa	lk 1 Width (in)
		X Wa	lk 1 Slope (%)
		X Wa	lk 1 X Slope (%)
	N/A	Ramp	inside XWalk1?
