## Access Compliance Report Public Rights-of-Way (Curb Ramps)

•		. /					I
Intersection ID: 50302 Main Street: PINE_CHAPEL_DR			Cros	Cross Street: PINE_TERRACE_CT				Location:	SW
ADA ID: FCA7D4B8D0D6	ID: FCA7D4B8D0D6 Ramp Type: Perp			Initial Pass/Fail: Pass Overall Compliance: No				o Severity Score:	5.25
Codes/Mitigation Info/Possible Solution				Field Measurements/Component Compliance					
	N CAR	Possible Solutions:		Compliance Description			Data Compliance Description		
		Remove & Replace Entire Ra	mn	N/A	Ramp Length (in)	48.5	Yes	Ramp Slope (%)	7.7
		Remove & Replace Gutter.		Yes	Ramp Width (in)	48.0	Yes	Ramp XSlope (%)	2.3
	COE OU			N/A	Flare Type LT	Sloped	N/A	Flare Type RT	N/A
	a Walder			N/A	Flare Slope LT (%)	2.7	Yes	Flare Slope RT (%)	4.8
ETG.	BL. P			N/A	Flare Traversable LT?	Yes	N/A	Flare Traversable RT?	Yes
	1 march			Yes	Landing Length (in)	48.3	Yes	DWS Provided?	Yes
the second second	1 Past	Surveyor Notes:		Yes	Landing Width (in)	48.0	Yes	DWS Contrast?	Yes

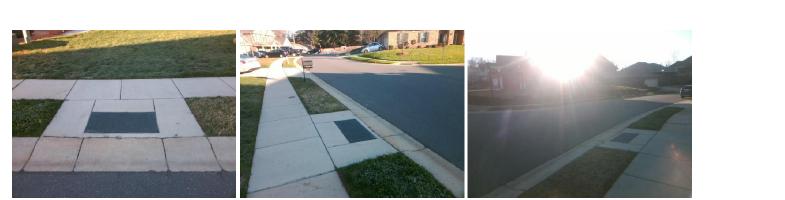
E Contraction		N/A		Yes	Landing Slope (%)	1.8	Yes	DWS Length (in)	24.0
				No	Landing X Slope (%)	3.3	Yes	DWS Full Width?	Yes
				N/A	Landing Curb? (Y/N)	No	No	DWS Offset (in)	4.5
				N/A	Shared Landing?	No			
		PROW/ADA:		Yes	Gutter Ponding?	No	No	Gutter Slope (%)	8.3
A A A A A A A A A A A A A A A A A A A		Not Found, R304.5.3, R305.2,		Yes	Gutter Lip Ht (in)	0.0	No	Gutter X Slope (%)	2.6
ALLAN CONTRACT		R304.5.4		N/A	Painted X Walk1?	No	N/A	Painted X Walk2?	N/A
					X Walk 1 Direction	To NE		X Walk 2 Direction	N/A
	ALLER			N/A	X Walk 1 Width (in)	N/A	N/A	X Walk 2 Width (in)	N/A
Street 1 Name	PINE CHAPEL DR				X Walk 1 Slope (%)	1.3		X Walk 2 Slope (%)	N/A
Stop Condition-Street 2	None				X Walk 1 X Slope (%)	2.5		X Walk 2 X Slope (%)	N/A
Street 2 Name	N/A			N/A	Ramp inside XWalk1?	N/A	N/A	Ramp inside XWalk2?	N/A
Stop Condition-Street 1	N/A				Road Slope (%)	N/A	N/A	Clear Space?	Yes
					Road X Slope (%)	N/A	N/A	Clear Space to XWalk (in)	N/A

Yes	Any Obstructions?	No	Yes	Storm Grate/Utility Hazard?	No
		Total Cost: \$	2600.00		Obstruction Type			Storm Grate/Utility Type	
						N/A			N/A

**Yes** Surface Condition? (G/P)

Good
