# Access Compliance Report Public Rights-of-Way (Curb Ramps)

Intersection ID: 4735      Main Street: EDSDALE\_PL      Cross Street: FELDBANK\_DR      Location: NW

ADA ID: FCB8DABB1FCD      Ramp Type: Perp      Initial Pass/Fail: Fail      Overall Compliance: No      Severity Score: 21.25

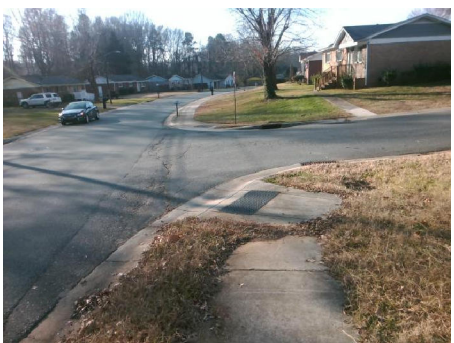
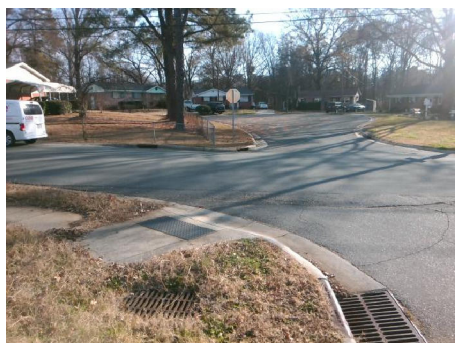
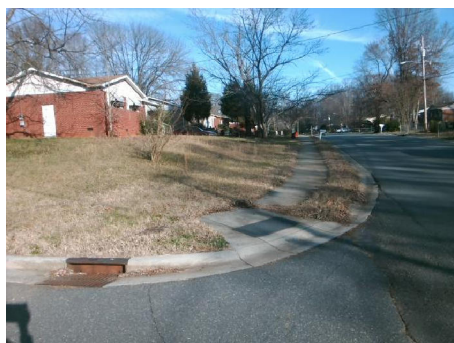
PROW/ADA:  
**Not Found, R304.5.1, R304.2.2**

Compliance	Description	Data	Compliance	Description	Data
N/A	Ramp Length (in)	83.0	No	Ramp Slope (%)	8.4
No	Ramp Width (in)	37.0	Yes	Ramp XSlope (%)	0.9
N/A	Flare Type LT	N/A	N/A	Flare Type RT	N/A
N/A	Flare Slope LT (%)	N/A	N/A	Flare Slope RT (%)	N/A
N/A	Flare Traversable LT?	N/A	N/A	Flare Traversable RT?	N/A
N/A	Landing Length (in)	N/A	N/A	DWS Provided?	N/A
N/A	Landing Width (in)	N/A	N/A	DWS Contrast?	N/A
N/A	Landing Slope (%)	N/A	N/A	DWS Length (in)	N/A
N/A	Landing X Slope (%)	N/A	N/A	DWS Full Width?	N/A
N/A	Landing Curb? (Y/N)	N/A	N/A	DWS Offset (in)	N/A
N/A	Shared Landing?	N/A			
N/A	Gutter Ponding?	N/A	N/A	Gutter Slope (%)	N/A
N/A	Gutter Lip Ht (in)	N/A	N/A	Gutter X Slope (%)	N/A
N/A	Painted X Walk1?	No	N/A	Painted X Walk2?	N/A
	X Walk 1 Direction	To S		X Walk 2 Direction	N/A
N/A	X Walk 1 Width (in)	N/A	N/A	X Walk 2 Width (in)	N/A
	X Walk 1 Slope (%)	3.0		X Walk 2 Slope (%)	N/A
	X Walk 1 X Slope (%)	2.5		X Walk 2 X Slope (%)	N/A

N/A	Ramp inside XWalk1?	N/A	N/A	Ramp inside XWalk2?	N/A
	Road Slope (%)	N/A	N/A	Clear Space?	N/A
	Road X Slope (%)	N/A	N/A	Clear Space to XWalk (in)	N/A
N/A	Any Obstructions?	N/A	N/A	Storm Grate/Utility Hazard?	N/A
	Obstruction Type			Storm Grate/Utility Type	
		N/A			N/A
			Yes	Surface Condition? (G/P)	Good

Possible Solutions:  
**Remove & Replace Entire Ramp.**

Total Cost:                      \$    **1850.00**
