# Access Compliance Report

## Public Rights-of-Way

### (Curb Ramps)

Intersection ID: 49250	Main Street: RIDGE_PATH_LN	Cross Street: BOOMERANG_WY	Location: S
ADA ID: FCB9CD90C60D	Ramp Type: BlendTrans1	Initial Pass/Fail: Fail	Overall Compliance: No
		Severity Score: 8.75

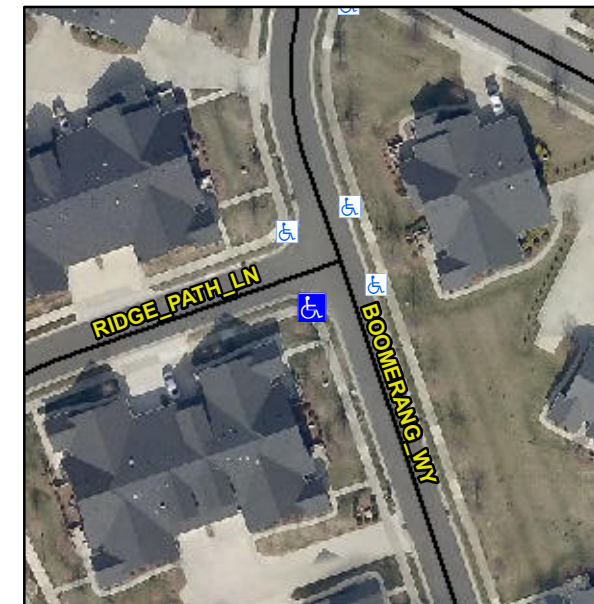
Compliance	Description	Data	Compliance	Description	Data
N/A	Ramp Length (in)	47.0	Yes	BlendTrans Slope (%)	3.8
No	Ramp Width (in)	47.0	Yes	BlendTrans XSlope (%)	1.2
N/A	Flare Type LT	N/A	N/A	Flare Type RT	N/A
N/A	Flare Slope LT (%)	N/A	N/A	Flare Slope RT (%)	N/A
N/A	Flare Traversable LT?	N/A	N/A	Flare Traversable RT?	N/A
N/A	Landing Length (in)	N/A	N/A	DWS Provided?	N/A
N/A	Landing Width (in)	N/A	N/A	DWS Contrast?	N/A
N/A	Landing Slope (%)	N/A	N/A	DWS Length (in)	N/A
N/A	Landing X Slope (%)	N/A	N/A	DWS Full Width?	N/A
N/A	Landing Curb? (Y/N)	N/A	N/A	DWS Offset (in)	N/A
N/A	Shared Landing?	N/A			
N/A	Gutter Ponding?	N/A	N/A	Gutter Slope (%)	N/A
N/A	Gutter Lip Ht (in)	0.5	N/A	Gutter X Slope (%)	N/A
N/A	Painted X Walk1?	No	N/A	Painted X Walk2?	No
	X Walk 1 Direction	To NE		X Walk 2 Direction	To NW
	X Walk 1 Width (in)	N/A		X Walk 2 Width (in)	N/A
	X Walk 1 Slope (%)	2.9		X Walk 2 Slope (%)	2.8
	X Walk 1 X Slope (%)	0.1		X Walk 2 X Slope (%)	0.0

N/A	Ramp inside XWalk1?	N/A	N/A	Ramp inside XWalk2?	N/A
	Road Slope (%)	0.1		Clear Space?	N/A
	Road X Slope (%)	2.9	N/A	Clear Space to XWalk (in)	N/A
N/A	Any Obstructions?	N/A	N/A	Storm Grate/Utility Hazard?	N/A
	Obstruction Type			Storm Grate/Utility Type	
		N/A			N/A
			Yes	Surface Condition? (G/P)	Good
			No	Curb Slope (%)	18.2

Possible Solutions:

**Remove & Replace Curb Ramp With Two New Directional Ramps or Equivalent.**

**Not Found, R304.5.1**

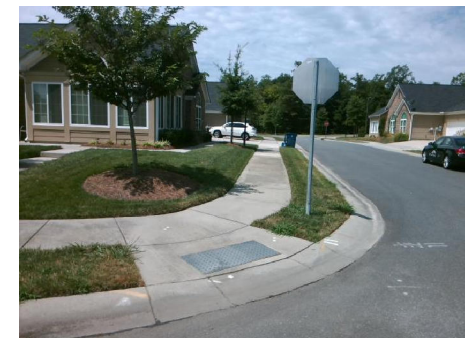
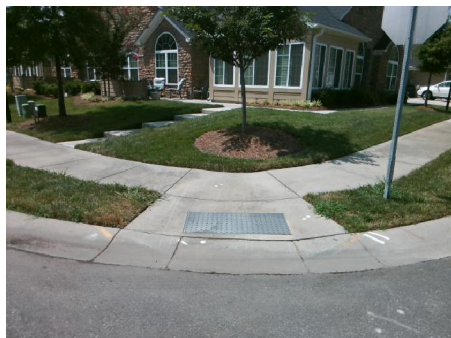
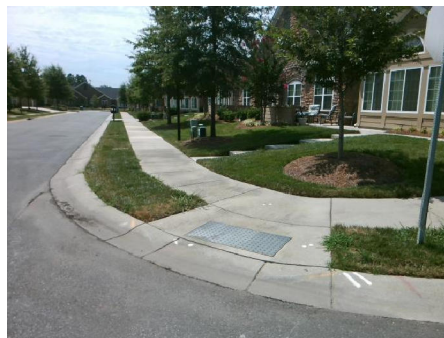
Street 1 Name **BOOMERANG WY**  
 Stop Condition-Street 1 **None**  
 Street 2 Name **RIDGE PATH LN**  
 Stop Condition-Street 2 **StopSign**
