Access Compliance Report

Public Rights-of-Way

(Curb Ramps)

| Intersection ID: 27965 | Main Street: BALLANTYNE_COUNTRY_CLUB_DR | Cross Street: POUND_HILL_LN | Location: SE |

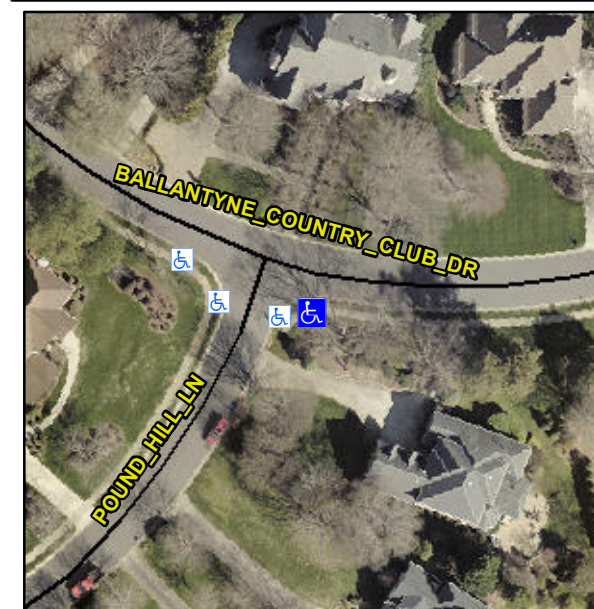
| ADA ID: FCBA6CB85FED | Ramp Type: Perp | Initial Pass/Fail: Fail | Overall Compliance: No |
| Severity Score: 13.75 | | | |

Not Found, R304.2.2, R304.5.3

| Compliance | Description | Data | Compliance | Description | Data |
|---|---|---|---|---|---|
| N/A | Ramp Length (in) | 46.0 | No | Ramp Slope (%) | 10.1 |
| Yes | Ramp Width (in) | 48.0 | No | Ramp XSlope (%) | 2.1 |

Remove & Replace Entire Ramp.
