Access Compliance Report

Public Rights-of-Way

(Curb Ramps)

Intersection ID: 45835	Main Street: CHRISTENBURY_HILLS_LN	Cross Street: KELDEN_WALKER_LN	Location: SW
ADA ID: FCC132DFEDE3	Ramp Type: Perp	Initial Pass/Fail: Fail	Overall Compliance: No
Severity Score: 58.75			
Codes/Mitigation Info/Possible Solution		Field Measurements/Component Compliance

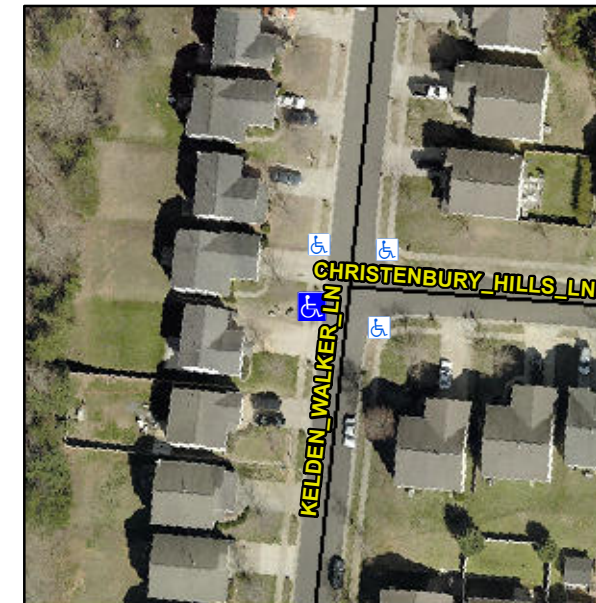
Not Found, R304.5.1, R304.2.2, R304.5.3

Compliance	Description	Data	Compliance	Description	Data
N/A	Ramp Length (in)	46.5	No	Ramp Slope (%)	15.6
No	Ramp Width (in)	47.5	No	Ramp XSlope (%)	10.3
N/A	Flare Type LT	N/A	N/A	Flare Type RT	N/A
N/A	Flare Slope LT (%)	N/A	N/A	Flare Slope RT (%)	N/A
N/A	Flare Traversable LT?	N/A	N/A	Flare Traversable RT?	N/A
N/A	Landing Length (in)	N/A	N/A	DWS Provided?	N/A
N/A	Landing Width (in)	N/A	N/A	DWS Contrast?	N/A
N/A	Landing Slope (%)	N/A	N/A	DWS Length (in)	N/A
N/A	Landing X Slope (%)	N/A	N/A	DWS Full Width?	N/A
N/A	Landing Curb? (Y/N)	N/A	N/A	DWS Offset (in)	N/A
N/A	Shared Landing?	N/A			
N/A	Gutter Ponding?	N/A	N/A	Gutter Slope (%)	N/A
N/A	Gutter Lip Ht (in)	N/A	N/A	Gutter X Slope (%)	N/A
N/A	Painted X Walk1?	No	N/A	Painted X Walk2?	N/A
	X Walk 1 Direction	To SE		X Walk 2 Direction	N/A
N/A	X Walk 1 Width (in)	N/A	N/A	X Walk 2 Width (in)	N/A
	X Walk 1 Slope (%)	3.4		X Walk 2 Slope (%)	N/A
	X Walk 1 X Slope (%)	9.7		X Walk 2 X Slope (%)	N/A

N/A	Ramp inside XWalk1?	N/A	N/A	Ramp inside XWalk2?	N/A
	Road Slope (%)	N/A	N/A	Clear Space?	N/A
	Road X Slope (%)	N/A	N/A	Clear Space to XWalk (in)	N/A
N/A	Any Obstructions?	N/A	N/A	Storm Grate/Utility Hazard?	N/A
	Obstruction Type			Storm Grate/Utility Type	
		N/A			N/A
			Yes	Surface Condition? (G/P)	Good

Remove & Replace Entire Ramp.
