Access Compliance Report Public Rights-of-Way (Curb Ramps)

Intersection ID: 13719 Main Street: CENTRAL_AV Cross Street: CAROLYN_DR Location: SW ADA ID: FCDB618D0A02 Ramp Type: Perp Initial Pass/Fail: Fail **Overall Compliance: No** Severity Score: 21.25

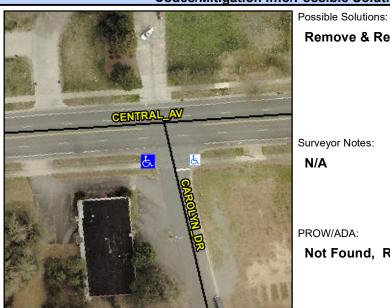
Field Measurements/Component Compliance						
Comp	liance Description	Data	Comp	liance	Description	Data
N/A	Ramp Length (in)	71.5	Yes	Ramp	Slope (%)	7.7
No	Ramp Width (in)	42.0	No	Ramp	XSlope (%)	6.1
N/A	Flare Type LT	N/A	N/A	Flare	Type RT	N/A
N/A	Flare Slope LT (%)	N/A	N/A	Flare	Slope RT (%)	N/A
N/A	Flare Traversable LT?	N/A	N/A	Flare	Traversable RT?	N/A
N/A	Landing Length (in)	N/A	N/A	DWS	Provided?	N/A
N/A	Landing Width (in)	N/A	N/A	DWS	Contrast?	N/A
N/A	Landing Slope (%)	N/A	N/A	DWS	Length (in)	N/A
N/A	Landing X Slope (%)	N/A	N/A	DWS	Full Width?	N/A
N/A	Landing Curb? (Y/N)	N/A	N/A	DWS	Offset (in)	N/A
N/A	Shared Landing?	N/A				
N/A	Gutter Ponding?	N/A	N/A	Gutte	r Slope (%)	N/A
N/A	Gutter Lip Ht (in)	N/A	N/A	Gutte	r X Slope (%)	N/A
N/A	Painted X Walk1?	No	N/A	Paint	ed X Walk2?	N/A
	X Walk 1 Direction	To E		X Wa	lk 2 Direction	N/A
N/A	X Walk 1 Width (in)	N/A	N/A	X Wa	lk 2 Width (in)	N/A
	X Walk 1 Slope (%)	3.5		X Wa	lk 2 Slope (%)	N/A

X Walk 1 X Slope (%)	8.0		X Wa	lk 2 X Slope (%)	N/A
N/A	Ramp inside XWalk1?	N/A	N/A	Ramp	inside XWalk2?	N/A
	Road Slope (%)	N/A	N/A	Clear	Space?	N/A
	Road X Slope (%)	N/A	N/A	Clear	Space to XWalk (in)	N/A
N/A	Any Obstructions?	N/A	N/A	Storm	Grate/Utility Hazard?	N/A
	Obstruction Type			Storm	Grate/Utility Type	
		N/A				N/A
			Yes	Surfa	ce Condition? (G/P)	Good

1 033ibic Odiations.	
	Remove & Replace Entire Ramp.	N
á		N
Ì		N
		N
		N
		N
N	Surveyor Notes:	N
	N/A	N
8		N
		N
		N
Ř	PROW/ADA:	N
7	Not Found, R304.5.1, R304.5.3	N
G	,	N
į		
		N
		N
