Access Compliance Report

Public Rights-of-Way

(Curb Ramps)

Intersection ID: 15940	Main Street: BURKLAND_DR	Cross Street: MARVIN_RD	Location: SW
ADA ID: FCE676678874	Ramp Type: PerpDiag	Initial Pass/Fail: Fail	Overall Compliance: No
Severity Score: 8.75			
Codes/Mitigation Info/Possible Solution		Field Measurements/Component Compliance

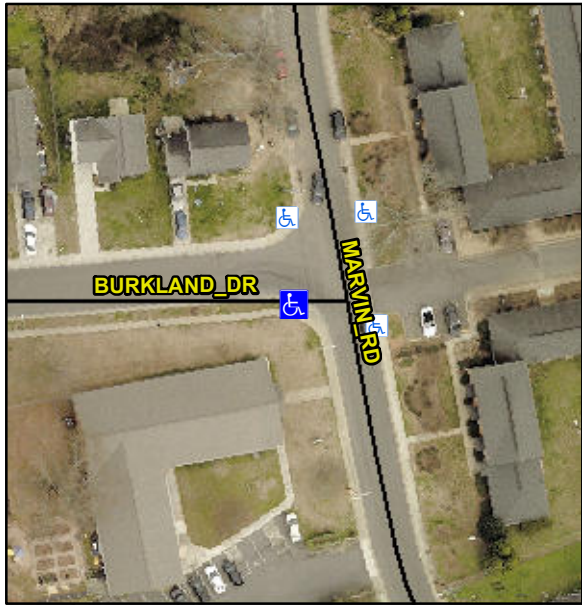
Compliance	Description	Data	Compliance	Description	Data
N/A	Ramp Length (in)	59.0	Yes	Ramp Slope (%)	7.2
No	Ramp Width (in)	36.0	Yes	Ramp XSlope (%)	1.9
N/A	Flare Type LT	N/A	N/A	Flare Type RT	N/A
N/A	Flare Slope LT (%)	N/A	N/A	Flare Slope RT (%)	N/A
N/A	Flare Traversable LT?	N/A	N/A	Flare Traversable RT?	N/A
N/A	Landing Length (in)	N/A	N/A	DWS Provided?	N/A
N/A	Landing Width (in)	N/A	N/A	DWS Contrast?	N/A
N/A	Landing Slope (%)	N/A	N/A	DWS Length (in)	N/A
N/A	Landing X Slope (%)	N/A	N/A	DWS Full Width?	N/A
N/A	Landing Curb? (Y/N)	N/A	N/A	DWS Offset (in)	N/A
N/A	Shared Landing?	N/A			
N/A	Gutter Ponding?	N/A	N/A	Gutter Slope (%)	N/A
N/A	Gutter Lip Ht (in)	N/A	N/A	Gutter X Slope (%)	N/A
N/A	Painted X Walk1?	No	N/A	Painted X Walk2?	No
	X Walk 1 Direction	To SE		X Walk 2 Direction	To N
N/A	X Walk 1 Width (in)	N/A	N/A	X Walk 2 Width (in)	N/A
	X Walk 1 Slope (%)	0.6		X Walk 2 Slope (%)	1.4
	X Walk 1 X Slope (%)	0.8		X Walk 2 X Slope (%)	1.2

N/A	Ramp inside XWalk1?	N/A	N/A	Ramp inside XWalk2?	N/A
	Road Slope (%)	0.2	N/A	Clear Space?	N/A
	Road X Slope (%)	1.5	N/A	Clear Space to XWalk (in)	N/A
N/A	Any Obstructions?	N/A	N/A	Storm Grate/Utility Hazard?	N/A
	Obstruction Type			Storm Grate/Utility Type	
		N/A			N/A
			Yes	Surface Condition? (G/P)	Good

Possible Solutions:												
	Remove & Replace Curb Ramp With Two New Directional Ramps or Equivalent.												
	Surveyor Notes:												
	N/A												
	PROW/ADA:												
	Not Found, R304.5.1												
Street 1 Name	MARVIN RD												
Stop Condition-Street 2	None												
Street 2 Name	BURKLAND DR												
Stop Condition-Street 1	StopSign												
Total Cost:		\$	3200.00
