# Access Compliance Report

## Public Rights-of-Way (Curb Ramps)

| Intersection ID: N/A | Main Street: S_BREVARD_ST | Cross Street: E_STONEWALL_ST | Location: SW |
| ADA ID: FCEED38AC765 | Ramp Type: Directional1 | Initial Pass/Fail: Pass | Overall Compliance: No |

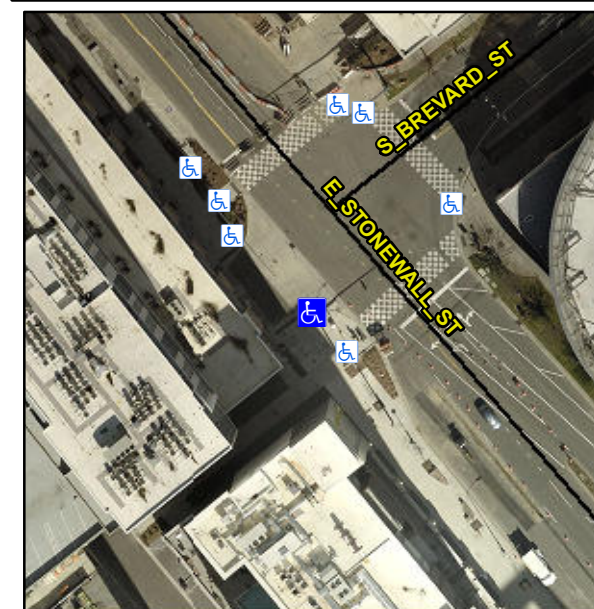
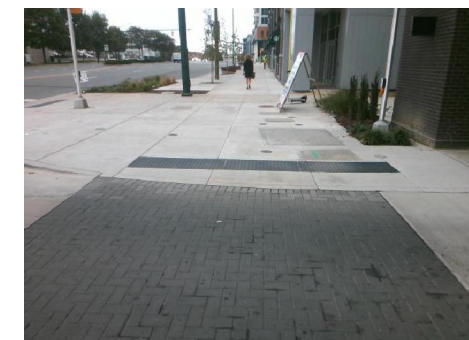
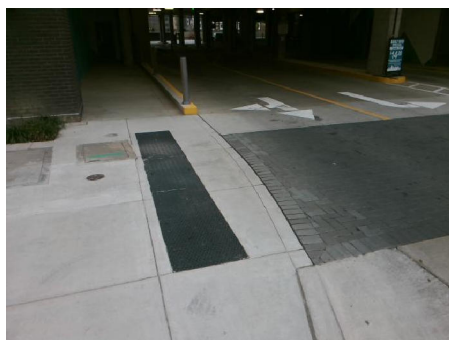
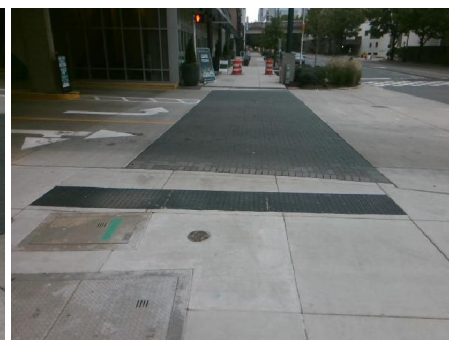
**R305.2**

| Compliance | Description | Data | Compliance | Description | Data |
|---|---|---|---|---|---|
| N/A | Landing Curb? (Y/N) | N/A | No | DWS Offset LT (in) | 13.0 |

**Remove & Replace Detectable Warning System.**

\$ 800.00
