Access Compliance Report

Public Rights-of-Way

(Curb Ramps)

Intersection ID: 13987	Main Street: KENHILL_DR	Cross Street: PARKMONT_DR	Location: SW
ADA ID: FCF20731FECF	Ramp Type: BlendTrans1	Initial Pass/Fail: Fail	Overall Compliance: No
		Severity Score: 10

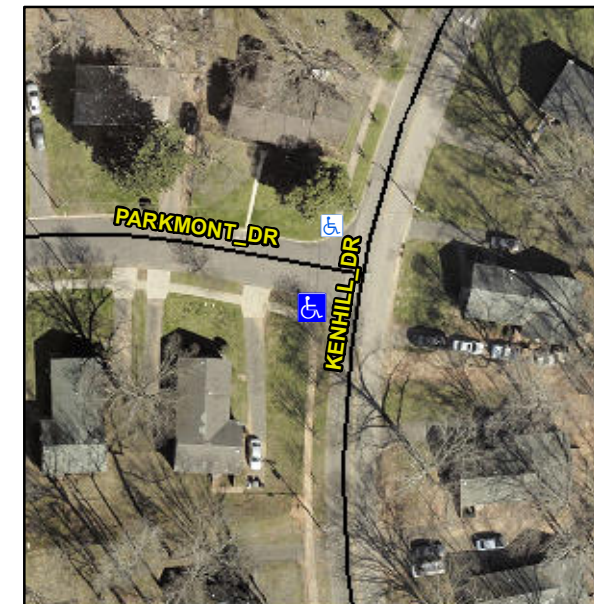
Not Found, R304.5.1, R304.5.3

Compliance	Description	Data	Compliance	Description	Data
N/A	Ramp Length (in)	73.0	Yes	BlendTrans Slope (%)	3.7
No	Ramp Width (in)	47.0	No	BlendTrans XSlope (%)	2.4
N/A	Flare Type LT	N/A	N/A	Flare Type RT	N/A
N/A	Flare Slope LT (%)	N/A	N/A	Flare Slope RT (%)	N/A
N/A	Flare Traversable LT?	N/A	N/A	Flare Traversable RT?	N/A
N/A	Landing Length (in)	N/A	N/A	DWS Provided?	N/A
N/A	Landing Width (in)	N/A	N/A	DWS Contrast?	N/A
N/A	Landing Slope (%)	N/A	N/A	DWS Length (in)	N/A
N/A	Landing X Slope (%)	N/A	N/A	DWS Full Width?	N/A
N/A	Landing Curb? (Y/N)	N/A	N/A	DWS Offset (in)	N/A
N/A	Shared Landing?	N/A			
N/A	Gutter Ponding?	N/A	N/A	Gutter Slope (%)	N/A
N/A	Gutter Lip Ht (in)	N/A	N/A	Gutter X Slope (%)	N/A
N/A	Painted X Walk1?	No	N/A	Painted X Walk2?	No
	X Walk 1 Direction	To E		X Walk 2 Direction	To N
	X Walk 1 Width (in)	N/A		X Walk 2 Width (in)	N/A
	X Walk 1 Slope (%)	4.2		X Walk 2 Slope (%)	1.4
	X Walk 1 X Slope (%)	1.6		X Walk 2 X Slope (%)	3.0

N/A	Ramp inside XWalk1?	N/A	N/A	Ramp inside XWalk2?	N/A
	Road Slope (%)	0.3		Clear Space?	N/A
	Road X Slope (%)	9.4	N/A	Clear Space to XWalk (in)	N/A
N/A	Any Obstructions?	N/A	N/A	Storm Grate/Utility Hazard?	N/A
	Obstruction Type			Storm Grate/Utility Type	
		N/A			N/A
			Yes	Surface Condition? (G/P)	Good
			No	Curb Slope (%)	14.6

Remove & Replace Curb Ramp With Two New Directional Ramps or Equivalent.
