Access Compliance Report Public Rights-of-Way (Curb Ramps)

Intersection ID: 28289Main Street: COVINGTON_CTCross Street: LANDING GREEN DRLocation:NEADA ID: FCF9C1111DE5Ramp Type: PerpDiagInitial Pass/Fail: PassOverall Compliance: NoSeverity Score:20

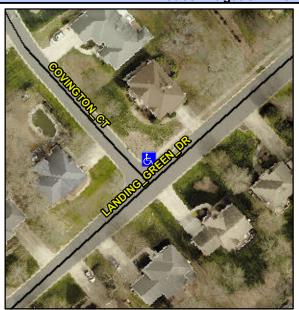
Not Found, R304.2.1, R304.2.2-Perp, R304.3.2-Para, R304.5.3, R304.2.3, R305.2, R302.7.2

Yes N/A Ramp Length (in) 43.5 Ramp Slope (%) 48.0 Yes Ramp XSlope (%) Yes Ramp Width (in) N/A N/A Flare Type LT Sloped Flare Type RT N/A 3.5 No Flare Slope RT (%) Flare Slope LT (%) N/A Flare Traversable LT? Nο N/A Flare Traversable RT? No N/A Yes DWS Provided? Landing Length (in) No Landing Width (in) N/A Yes **DWS Contrast?** N/A Yes No Landing Slope (%) DWS Length (in) No Landing X Slope (%) N/A Yes DWS Full Width? N/A Landing Curb? (Y/N) No No DWS Offset (in) N/A Shared Landing? No Gutter Ponding? Yes Gutter Slope (%) Yes No No Gutter Lip Ht (in) 0.5 No Gutter X Slope (%) N/A Painted X Walk1? No N/A Painted X Walk2? X Walk 1 Direction To SW X Walk 2 Direction N/A N/A X Walk 1 Width (in) X Walk 2 Width (in) X Walk 1 Slope (%) 0.6 X Walk 2 Slope (%) X Walk 1 X Slope (%) 0.8 X Walk 2 X Slope (%) N/A N/A N/A Ramp inside XWalk2? Ramp inside XWalk1? Road Slope (%) 0.3 N/A Clear Space? N/A Road X Slope (%) 1.1 Clear Space to XWalk (in) No Yes Any Obstructions? Yes Storm Grate/Utility Hazard? **Obstruction Type** Storm Grate/Utility Type

Remove & Replace Curb Ramp With Two New Directional Ramps or Equivalent. Remove & Replace Gutter.
