Access Compliance Report

Public Rights-of-Way

(Curb Ramps)

Intersection ID: 3026	Main Street: FOX_HILL_DR	Cross Street: FOX_TROT_DR	Location:	W
ADA ID: FCFADF57B8A7	Ramp Type: Perp	Initial Pass/Fail: Fail	Overall Compliance: No	Severity Score: 8.75
Codes/Mitigation Info/Possible Solution		Field Measurements/Component Compliance

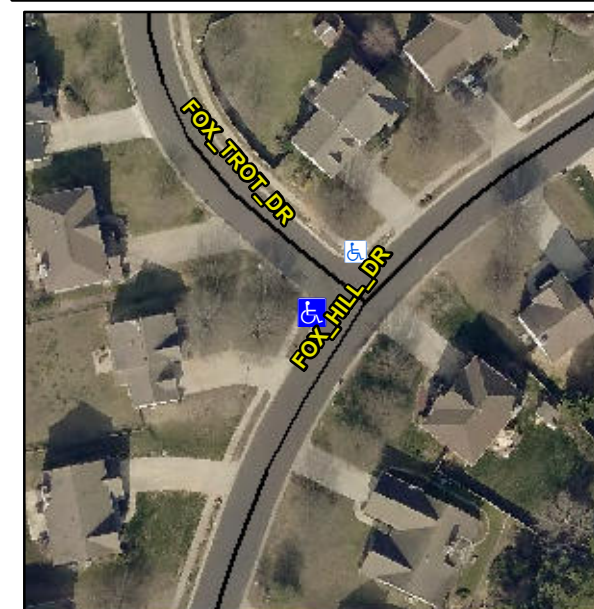
Not Found, R304.5.1

Compliance	Description	Data	Compliance	Description	Data
N/A	Ramp Length (in)	38.0	Yes	Ramp Slope (%)	6.5
No	Ramp Width (in)	47.5	Yes	Ramp XSlope (%)	0.1
N/A	Flare Type LT	N/A	N/A	Flare Type RT	N/A
N/A	Flare Slope LT (%)	N/A	N/A	Flare Slope RT (%)	N/A
N/A	Flare Traversable LT?	N/A	N/A	Flare Traversable RT?	N/A
N/A	Landing Length (in)	N/A	N/A	DWS Provided?	N/A
N/A	Landing Width (in)	N/A	N/A	DWS Contrast?	N/A
N/A	Landing Slope (%)	N/A	N/A	DWS Length (in)	N/A
N/A	Landing X Slope (%)	N/A	N/A	DWS Full Width?	N/A
N/A	Landing Curb? (Y/N)	N/A	N/A	DWS Offset (in)	N/A
N/A	Shared Landing?	N/A			
N/A	Gutter Ponding?	N/A	N/A	Gutter Slope (%)	N/A
N/A	Gutter Lip Ht (in)	N/A	N/A	Gutter X Slope (%)	N/A
N/A	Painted X Walk1?	No	N/A	Painted X Walk2?	N/A
	X Walk 1 Direction	To NE		X Walk 2 Direction	N/A
N/A	X Walk 1 Width (in)	N/A	N/A	X Walk 2 Width (in)	N/A
	X Walk 1 Slope (%)	1.0		X Walk 2 Slope (%)	N/A
	X Walk 1 X Slope (%)	0.1		X Walk 2 X Slope (%)	N/A

N/A	Ramp inside XWalk1?	N/A	N/A	Ramp inside XWalk2?	N/A
	Road Slope (%)	N/A	N/A	Clear Space?	N/A
	Road X Slope (%)	N/A	N/A	Clear Space to XWalk (in)	N/A
N/A	Any Obstructions?	N/A	N/A	Storm Grate/Utility Hazard?	N/A
	Obstruction Type			Storm Grate/Utility Type	
		N/A			N/A
			Yes	Surface Condition? (G/P)	Good

Remove & Replace Entire Ramp.

Total Cost: \$ 1850.00
