Access Compliance Report Public Rights-of-Way (Curb Ramps)

Intersection ID: 10036927 Main Street: S SHARON AMITY RD Cross Street: N/A Location: SW Initial Pass/Fail: Fail **Overall Compliance: No Severity Score:** 12.5 **ADA ID: FCFE0CBCC2E8** Ramp Type: PerpDiag

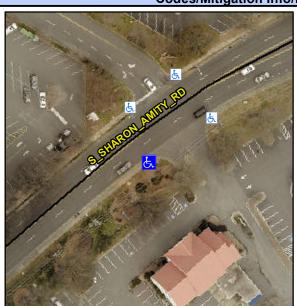
Possible Solutions: Compliance Description N/A Remove & Replace Curb Ramp With Two New Directional Ramps or Equivalent. Surveyor Notes: N/A PROW/ADA: Not Found, R304.2.2
