## Access Compliance Report Public Rights-of-Way (Curb Ramps)

Intersection ID: 4727	Main Street: BRIGGS_DR				Cross Street: LOWEN_RD				Location:	
ADA ID: FCFE663F64E0		Ramp Type: PerpDiag			Initial Pass/Fail: Fail Overall Compliand			nce. N		
Codes/Mitigation Info/Possible Solution				Interal	Field Measurements/Component Compliance					
Possible Solutions:				Compliance Description Data Compliance Description Data						
				<b>A</b> <i>P</i> (1)			52.0	Yes		
		Remove & Replace Curb F Two New Directional Ram	-	with	N/A No	Ramp Length (in) Ramp Width (in)	52.0 36.0	No	Ramp Slope (%)	6.8 9.0
		Equivalent.			NO N/A	1 ( )	36.0 N/A	NO N/A	Ramp XSlope (%)	9.0 N/A
						Flare Type LT			Flare Type RT	
					N/A	Flare Slope LT (%)	N/A	N/A	Flare Slope RT (%)	N/A
				N/A	Flare Traversable LT?	N/A	N/A	Flare Traversable RT?	N/A	
				N/A	Landing Length (in)	N/A	N/A	DWS Provided?	N/A	
		Surveyor Notes:			N/A	Landing Width (in)	N/A	N/A	DWS Contrast?	N/A
		N/A			N/A	Landing Slope (%)	N/A		DWS Length (in)	N/A

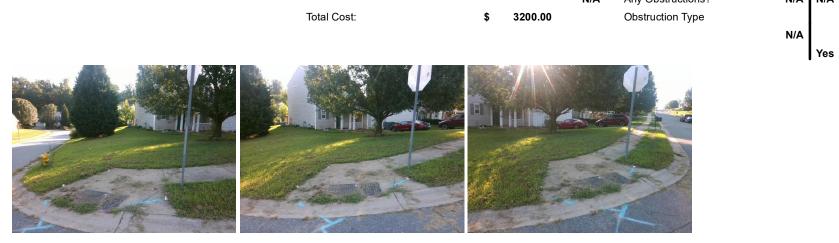
a			N/A	Landing X Slope (%)	N/A	N/A	DWS Full Width?	N/A
A A A A A A A A A A A A A A A A A A A					N/A	Landing Curb? (Y/N)	N/A	N/A	DWS Offset (in)	N/A
					N/A	Shared Landing?	N/A			
		PROW/ADA:			N/A	Gutter Ponding?	N/A	N/A	Gutter Slope (%)	N/A
		Not Found, R304.5.1, R30	4.5.3		N/A	Gutter Lip Ht (in)	N/A	N/A	Gutter X Slope (%)	N/A
and the second of the					N/A	Painted X Walk1?	No	N/A	Painted X Walk2?	No
	Topol - A					X Walk 1 Direction	To NW		X Walk 2 Direction	To SW
					N/A	X Walk 1 Width (in)	N/A	N/A	X Walk 2 Width (in)	N/A
Street 1 Name	LOWEN RD					X Walk 1 Slope (%)	1.1		X Walk 2 Slope (%)	10.1
Stop Condition-Street 2	None					X Walk 1 X Slope (%)	8.9		X Walk 2 X Slope (%)	3.4
Street 2 Name	BRIGGS DR				N/A	Ramp inside XWalk1?	N/A	N/A	Ramp inside XWalk2?	N/A
Stop Condition-Street 1	StopSign					Road Slope (%)	9.8	N/A	Clear Space?	N/A
	. •					Road X Slope (%)	5.7	N/A	Clear Space to XWalk (in)	N/A

N/A	Any Obstructions?	N/A	N/A	Storm Grate/Utility Hazard?	N/A
		Total Cost:	\$	3200.00		Obstruction Type			Storm Grate/Utility Type	
			•			51	N/A			N/A
								1
