Access Compliance Report Public Rights-of-Way (Curb Ramps)

-							
Intersection ID: 13413 Main Street: OLD_STEELE_CREEK_RD			Cross	Cross Street: SEYMOUR_DR				Location:	SW
ADA ID: FD006E3D20	FD006E3D2097 Ramp Type: PerpDiag			Initial Pass/Fail: Fail Overall Compliance: No				o Severity Score:	21.25
Codes/Mitigation Info/Possible Solution				Field Measurements/Component Compliance					
Support of the second		Possible Solutions:						Compliance Description	
		Remove & Replace Curb Ram	n With	N/A	Ramp Length (in)	58.0	No	Ramp Slope (%)	8.7
1 James		Two New Directional Ramps or Equivalent.		No	Ramp Width (in)	45.0	Yes	Ramp XSlope (%)	0.9
Mark - h				N/A	Flare Type LT	N/A	N/A	Flare Type RT	N/A
and the second second				N/A	Flare Slope LT (%)	N/A	N/A	Flare Slope RT (%)	N/A

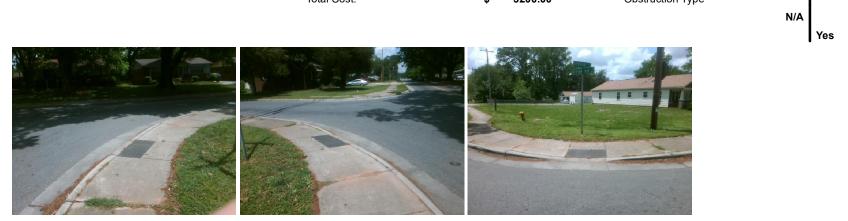
- ATT				N/A	Flare Traversable LT?	N/A	N/A	Flare Traversable RT?	N/A
SSUMOUR DR	e 📶			N/A	Landing Length (in)	N/A	N/A	DWS Provided?	N/A
				N/A	Landing Width (in)	N/A	N/A	DWS Contrast?	N/A

R. All		N/A		N/A	Landing Slope (%)	N/A	N/A	DWS Length (in)	N/A
	G.			N/A	Landing X Slope (%)	N/A	N/A	DWS Full Width?	N/A
				N/A	Landing Curb? (Y/N)	N/A	N/A	DWS Offset (in)	N/A
	9			N/A	Shared Landing?	N/A		ζ, γ	
and the second second		PROW/ADA:		N/A	Gutter Ponding?	N/A	N/A	Gutter Slope (%)	N/A
	Ja I La	Not Found, R304.5.1, R304.2.	2	N/A	Gutter Lip Ht (in)	N/A	N/A	Gutter X Slope (%)	N/A
MARENE DR				N/A	Painted X Walk1?	No	N/A	Painted X Walk2?	No
					X Walk 1 Direction	To E		X Walk 2 Direction	To N
				N/A	X Walk 1 Width (in)	N/A	N/A	X Walk 2 Width (in)	N/A
Street 1 Name	OLD STEELE CREEK RD	-			X Walk 1 Slope (%)	2.0		X Walk 2 Slope (%)	4.6
Stop Condition-Street 2	None				X Walk 1 X Slope (%)	3.8		X Walk 2 X Slope (%)	2.3
Street 2 Name	SEYMOUR DR			N/A	Ramp inside XWalk1?	N/A	N/A	Ramp inside XWalk2?	N/A
Stop Condition-Street 1	StopSign				Road Slope (%)	0.7	N/A	Clear Space?	N/A
					Road X Slope (%)	4.9	N/A	Clear Space to XWalk (in)	N/A

N/A	Any Obstructions?	N/A	N/A	Storm Grate/Utility Hazard?	N/A
		Total Cost: \$	3200.00		Obstruction Type			Storm Grate/Utility Type	
						N/A			N/A

s Surface Condition? (G/P)

Good
