Access Compliance Report

Public Rights-of-Way

(Curb Ramps)

Intersection ID: 13767	Main Street: E_5TH_ST	Cross Street: PARK_DR	Location: E
ADA ID: FD1551D1DA08	Ramp Type: PerpDiag	Initial Pass/Fail: Fail	Overall Compliance: No
		Severity Score: 12.5

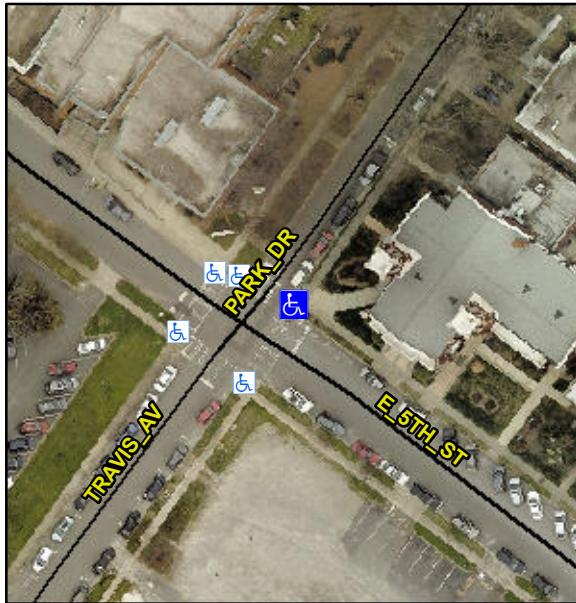
Compliance	Description	Data	Compliance	Description	Data
N/A	Ramp Length (in)	58.0	No	Ramp Slope (%)	11.0
Yes	Ramp Width (in)	80.0	Yes	Ramp XSlope (%)	2.0
N/A	Flare Type LT	N/A	N/A	Flare Type RT	N/A
N/A	Flare Slope LT (%)	N/A	N/A	Flare Slope RT (%)	N/A
N/A	Flare Traversable LT?	N/A	N/A	Flare Traversable RT?	N/A
N/A	Landing Length (in)	N/A	N/A	DWS Provided?	N/A
N/A	Landing Width (in)	N/A	N/A	DWS Contrast?	N/A
N/A	Landing Slope (%)	N/A	N/A	DWS Length (in)	N/A
N/A	Landing X Slope (%)	N/A	N/A	DWS Full Width?	N/A
N/A	Landing Curb? (Y/N)	N/A	N/A	DWS Offset (in)	N/A
N/A	Shared Landing?	N/A			
N/A	Gutter Ponding?	N/A	N/A	Gutter Slope (%)	N/A
N/A	Gutter Lip Ht (in)	N/A	N/A	Gutter X Slope (%)	N/A
N/A	Painted X Walk1?	Yes	N/A	Painted X Walk2?	Yes
	X Walk 1 Direction	To NW		X Walk 2 Direction	To SW
N/A	X Walk 1 Width (in)	111.5	N/A	X Walk 2 Width (in)	113.0
	X Walk 1 Slope (%)	2.1		X Walk 2 Slope (%)	4.2
	X Walk 1 X Slope (%)	0.3		X Walk 2 X Slope (%)	1.1

N/A	Ramp inside XWalk1?	Yes	N/A	Ramp inside XWalk2?	Yes
	Road Slope (%)	2.2	N/A	Clear Space?	N/A
	Road X Slope (%)	1.8	N/A	Clear Space to XWalk (in)	N/A
N/A	Any Obstructions?	N/A	N/A	Storm Grate/Utility Hazard?	N/A
	Obstruction Type			Storm Grate/Utility Type	
		N/A			N/A
		Yes		Surface Condition? (G/P)	Good

Remove & Replace Curb Ramp With Two New Directional Ramps or Equivalent.
