Access Compliance Report Public Rights-of-Way (Curb Ramps)

Intersection ID: 48771	Main Street: LUMBER_LN		Cross Street: TURNING_WHEEL_DR				Location:	SE		
ADA ID: FD1CF2BE46C7	ID: FD1CF2BE46C7 Ramp Type: Perp		Initial Pass/Fail: Fail Overall Compliance: No				o Severity Score:	12.5		
Codes/Mitigation Info/Possible Solution				Field Measurements/Component Compliance						
Sector Company	The second second second	Possible Solutions:	Compliance Description			Data	Data Compliance Description			
	10312	Remove & Replace Entire Ramp		N/A	Ramp Length (in)	71.5	No	Ramp Slope (%)	8.7	
	No. Your	1		Yes	Ramp Width (in)	48.0	Yes	Ramp XSlope (%)	1.5	
Landra T-	- A A			N/A	Flare Type LT	N/A	N/A	Flare Type RT	N/A	
	CALL CALL			N/A	Flare Slope LT (%)	N/A	N/A	Flare Slope RT (%)	N/A	
	A 14 10 M			N/A	Flare Traversable LT?	N/A	N/A	Flare Traversable RT?	N/A	
				N/A	Landing Length (in)	N/A	N/A	DWS Provided?	N/A	
		Surveyor Notes:		N/A	Landing Width (in)	N/A	N/A	DWS Contrast?	N/A

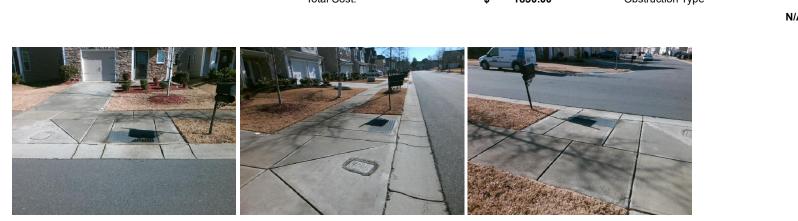
N/A		N/A	Landing Slope (%)	N/A	N/A	DWS Length (in)	N/A	
6.	1			N/A	Landing X Slope (%)	N/A	N/A	DWS Full Width?	N/A	
				N/A	Landing Curb? (Y/N)	N/A	N/A	DWS Offset (in)	N/A	
		5 		N/A	Shared Landing?	N/A				
	2 all of the	PROW/ADA:		N/A	Gutter Ponding?	N/A	N/A	Gutter Slope (%)	N/A	
	and and and	Not Found, R304.2.2		N/A	Gutter Lip Ht (in)	N/A	N/A	Gutter X Slope (%)	N/A	
	A A	<i>,</i>		N/A	Painted X Walk1?	No	N/A	Painted X Walk2?	N/A	
	and the second second				X Walk 1 Direction	To W		X Walk 2 Direction	N/A	
				N/A	X Walk 1 Width (in)	N/A	N/A	X Walk 2 Width (in)	N/A	
Street 1 Name TURNIN	NG WHEEL DR				X Walk 1 Slope (%)	4.5		X Walk 2 Slope (%)	N/A	
Stop Condition-Street 2	None				X Walk 1 X Slope (%)	2.6		X Walk 2 X Slope (%)	N/A	
Street 2 Name	N/A			N/A	Ramp inside XWalk1?	N/A	N/A	Ramp inside XWalk2?	N/A	
Stop Condition-Street 1	N/A				Road Slope (%)	N/A	N/A	Clear Space?	N/A	
					Road X Slope (%)	N/A	N/A	Clear Space to XWalk (in)	N/A

N/A	Any Obstructions?	N/A	N/A	Storm Grate/Utility Hazard?	N/A	
		Total Cost: \$	1850.00		Obstruction Type			Storm Grate/Utility Type		
						N/A			N/A

Yes Surface Condition? (G/P) Good
