Access Compliance Report

Public Rights-of-Way

(Curb Ramps)

Intersection ID: 48945	Main Street: DAVID_JENNINGS_AV	Cross Street: CALDWELL_RIDGE_PY	Location: W
ADA ID: FD280DE19A55	Ramp Type: Combination1	Initial Pass/Fail: Fail	Overall Compliance: No
Severity Score: 10			
Codes/Mitigation Info/Possible Solution		Field Measurements/Component Compliance

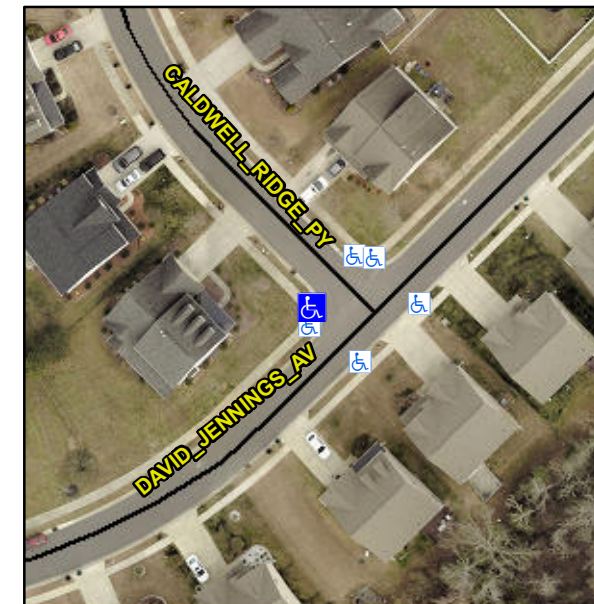
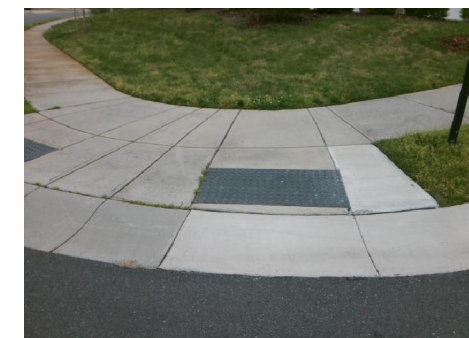
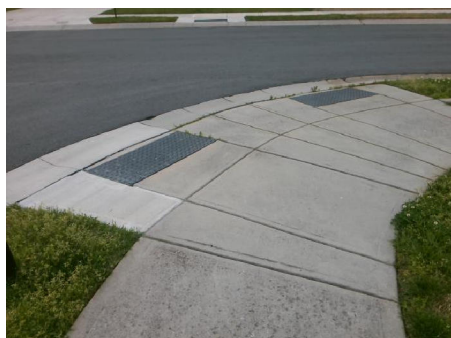
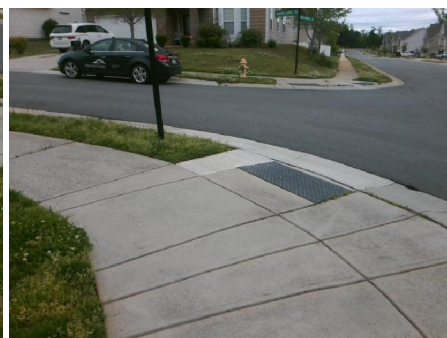
Not Found, R304.5.1, R304.5.3

Compliance	Description	Data	Compliance	Description	Data
N/A	Ramp Length LT (in)	12.5	N/A	Ramp Length RT (in)	11.5
Yes	Ramp Width LT (in)	60.5	Yes	Ramp Width RT (in)	58.5
Yes	Ramp Slope LT (%)	7.1	Yes	Ramp Slope RT (%)	6.8
No	Ramp XSlope LT (%)	3.2	No	Ramp XSlope RT (%)	2.5
N/A	Ramp Length (in)	48.5	Yes	Ramp Slope (%)	7.5
No	Ramp Width (in)	45.0	No	Ramp XSlope (%)	3.6
N/A	Flare Type LT	N/A	N/A	Flare Type RT	N/A
N/A	Flare Slope LT (%)	N/A	N/A	Flare Slope RT (%)	N/A
N/A	Flare Traversable LT?	N/A	N/A	Flare Traversable RT?	N/A
N/A	Landing Length (in)	N/A	N/A	DWS Provided?	N/A
N/A	Landing Width (in)	N/A	N/A	DWS Contrast?	N/A
N/A	Landing Slope (%)	N/A	N/A	DWS Length (in)	N/A
N/A	Landing X Slope (%)	N/A	N/A	DWS Full Width?	N/A
N/A	Landing Curb? (Y/N)	N/A	N/A	DWS Offset (in)	N/A
N/A	Shared Landing?	N/A			
N/A	Gutter Ponding?	N/A	N/A	Gutter Slope (%)	N/A
N/A	Gutter Lip Ht (in)	N/A	N/A	Gutter X Slope (%)	N/A
N/A	Painted X Walk1?	No	N/A	Painted X Walk2?	N/A

X Walk 1 Direction	To NE		X Walk 2 Direction	N/A
	X Walk 1 Width (in)	N/A		X Walk 2 Width (in)	N/A
	X Walk 1 Slope (%)	0.2		X Walk 2 Slope (%)	N/A
	X Walk 1 X Slope (%)	3.9		X Walk 2 X Slope (%)	N/A
N/A	Ramp inside XWalk1?	N/A	N/A	Ramp inside XWalk2?	N/A
	Road Slope (%)	N/A		Clear Space?	N/A
	Road X Slope (%)	N/A	N/A	Clear Space to XWalk (in)	N/A
			N/A	Any Obstruction?	N/A
				Obstruction Type	N/A
			N/A	Storm Grate/Utility Hazard?	N/A
				Storm Grate/Utility Type	N/A
			Yes	Surface Condition? (G/P)	Good
				Curb Slope (%)	22.8

Possible Solutions:

Remove & Replace Entire Ramp.
