Access Compliance Report

Public Rights-of-Way

(Curb Ramps)

Intersection ID: 8592	Main Street: PERIWINKLE_HILL_AV	Cross Street: IKEA_BV	Location:	E
ADA ID: FD2BA1D31254	Ramp Type: Directional1	Initial Pass/Fail: Pass	Overall Compliance: No	Severity Score: 0

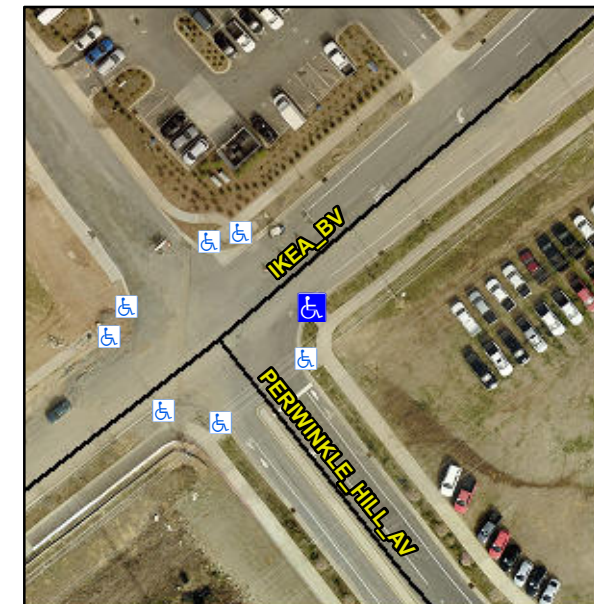
R304.5.3, R302.7

Compliance	Description	Data	Compliance	Description	Data
N/A	Ramp Length (in)	84.0	Yes	Grade Break?	Yes
Yes	Ramp Width (in)	90.0	No	Grade Break Slope (%)	7.5
Yes	Ramp Slope (%)	5.8	Yes	Grade Break XSlope (%)	1.9
Yes	Ramp XSlope (%)	1.9			
N/A	Flare Type LT	N/A	N/A	Flare Type RT	N/A
N/A	Flare Slope LT (%)	N/A	N/A	Flare Slope RT (%)	N/A
N/A	Flare Traversable LT?	N/A	N/A	Flare Traversable RT?	N/A
Yes	Landing Length (in)	80.0	Yes	DWS Provided?	Yes
Yes	Landing Width (in)	69.0	Yes	DWS Contrast?	Yes
Yes	Landing Slope (%)	0.2	Yes	DWS Length (in)	24.5
No	Landing X Slope (%)	5.2	Yes	DWS Full Width?	Yes
N/A	Landing Curb? (Y/N)	N/A	Yes	DWS Offset LT (in)	24.0
N/A	Shared Landing?	No	Yes	DWS Offset RT (in)	0.0
No	Gutter Ponding?	Yes	Yes	Gutter Slope (%)	2.1
Yes	Gutter Lip Ht (in)	0.0	Yes	Gutter X Slope (%)	3.4
N/A	Painted X Walk1?	No		Road Slope (%)	1.8
	X Walk 1 Direction	To NW		Road X Slope (%)	3.5
	X Walk 1 Width (in)	N/A		Clear Space?	Yes

X Walk 1 Slope (%)	1.8	N/A	Clear Space to XWalk (in)	N/A
	X Walk 1 X Slope (%)	3.5	Yes	Storm Grate/Utility Hazard?	No
N/A	Ramp inside XWalk1?	N/A		Storm Grate/Utility Type	
Yes	Any Obstructions?	No			N/A
	Obstruction Type		Yes	Surface Condition? (G/P)	Good
			N/A	Curb Slope (%)	N/A

**Remove & Replace Entire Ramp.
Gutter Ponding Observed.**
