Access Compliance Report

Public Rights-of-Way

(Curb Ramps)

Intersection ID: N/A	Main Street: CLARKSON_ST	Cross Street: POST_ST	Location:	N
ADA ID: FD39B6F0A578	Ramp Type: Perp	Initial Pass/Fail: Fail	Overall Compliance: No	Severity Score: 1.25
Codes/Mitigation Info/Possible Solution		Field Measurements/Component Compliance

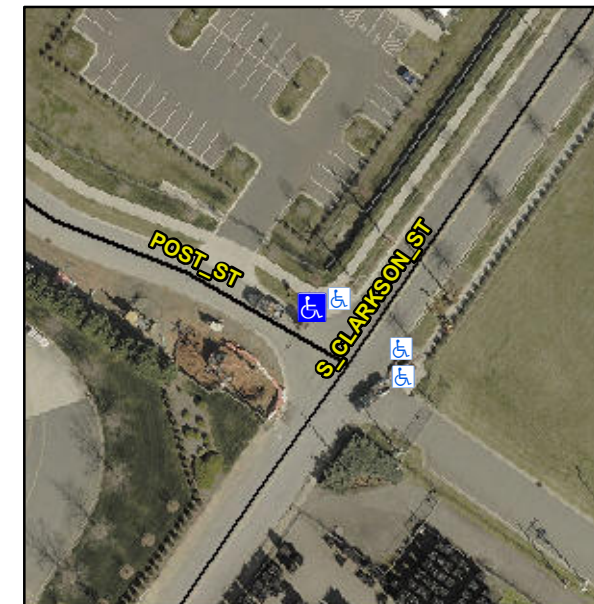
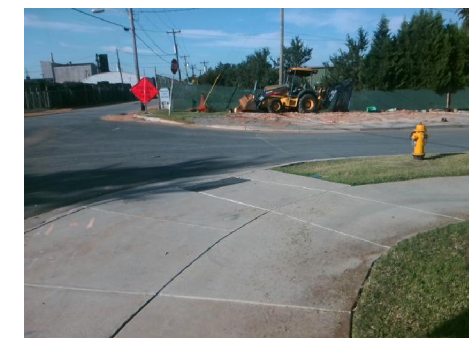
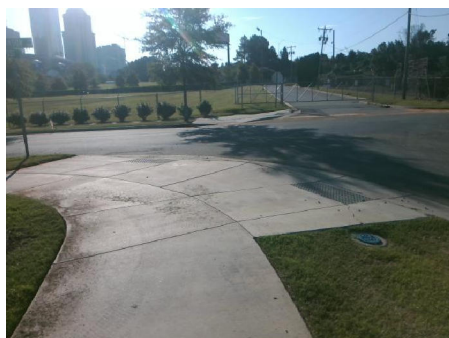
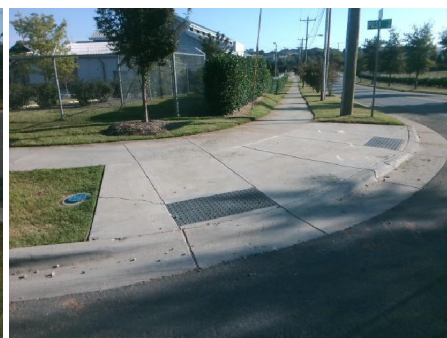
Not Found, R304.5.3

Compliance	Description	Data	Compliance	Description	Data
N/A	Ramp Length (in)	97.0	Yes	Ramp Slope (%)	5.4
Yes	Ramp Width (in)	48.0	No	Ramp XSlope (%)	2.2
N/A	Flare Type LT	N/A	N/A	Flare Type RT	N/A
N/A	Flare Slope LT (%)	N/A	N/A	Flare Slope RT (%)	N/A
N/A	Flare Traversable LT?	N/A	N/A	Flare Traversable RT?	N/A
N/A	Landing Length (in)	N/A	N/A	DWS Provided?	N/A
N/A	Landing Width (in)	N/A	N/A	DWS Contrast?	N/A
N/A	Landing Slope (%)	N/A	N/A	DWS Length (in)	N/A
N/A	Landing X Slope (%)	N/A	N/A	DWS Full Width?	N/A
N/A	Landing Curb? (Y/N)	N/A	N/A	DWS Offset (in)	N/A
N/A	Shared Landing?	N/A			
N/A	Gutter Ponding?	N/A	N/A	Gutter Slope (%)	N/A
N/A	Gutter Lip Ht (in)	N/A	N/A	Gutter X Slope (%)	N/A
N/A	Painted X Walk1?	No	N/A	Painted X Walk2?	N/A
	X Walk 1 Direction	To SW		X Walk 2 Direction	N/A
N/A	X Walk 1 Width (in)	N/A	N/A	X Walk 2 Width (in)	N/A
	X Walk 1 Slope (%)	3.2		X Walk 2 Slope (%)	N/A
	X Walk 1 X Slope (%)	3.4		X Walk 2 X Slope (%)	N/A

N/A	Ramp inside XWalk1?	N/A	N/A	Ramp inside XWalk2?	N/A
	Road Slope (%)	N/A	N/A	Clear Space?	N/A
	Road X Slope (%)	N/A	N/A	Clear Space to XWalk (in)	N/A
N/A	Any Obstructions?	N/A	N/A	Storm Grate/Utility Hazard?	N/A
	Obstruction Type			Storm Grate/Utility Type	
		N/A			N/A
			Yes	Surface Condition? (G/P)	Good

Remove & Replace Entire Ramp.
