Access Compliance Report

Public Rights-of-Way

(Curb Ramps)

Intersection ID: 12695	Main Street: S_CALDWELL_ST	Cross Street: E TRADE ST	Location: SW
ADA ID: FD3A0F31B62F	Ramp Type: Perp	Initial Pass/Fail: Fail	Overall Compliance: No
		Severity Score: 8.75

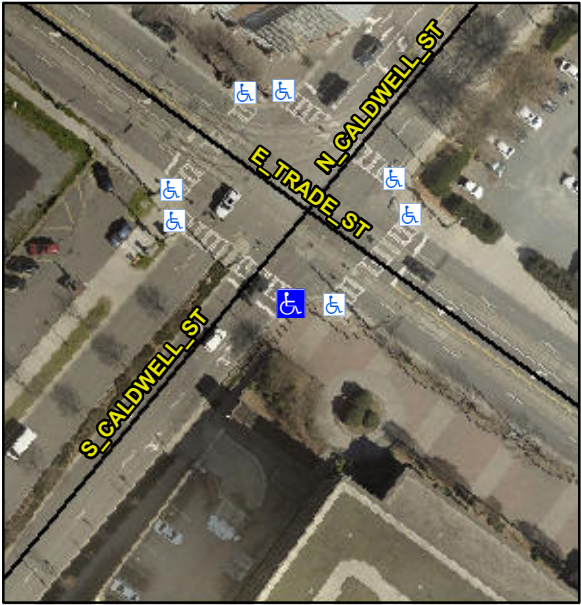
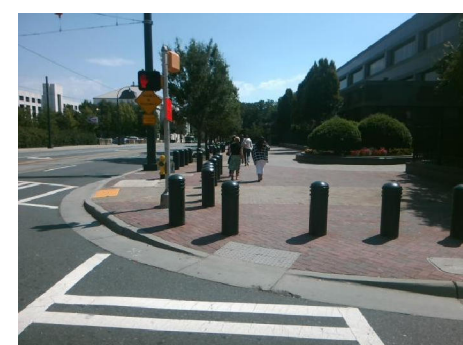
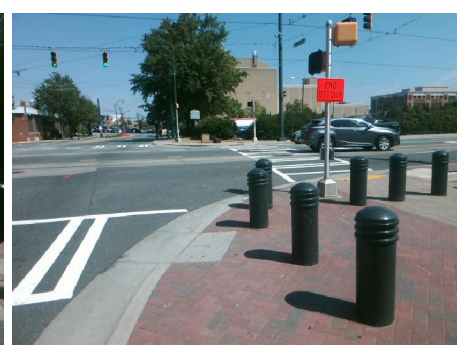
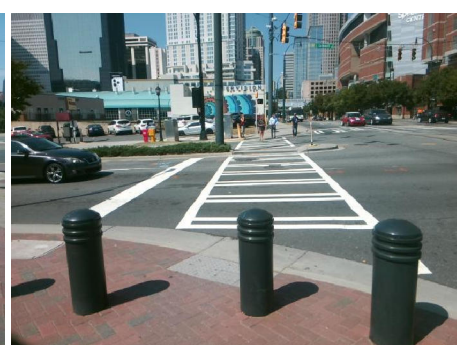
Possible Solutions:		Compliance	Description	Data
	Remove & Replace Entire Ramp.		Yes	Ramp Slope (%)	7.3
			No	Ramp Width (in)	1.4
			N/A	Flare Type LT	N/A
			N/A	Flare Slope LT (%)	N/A
			N/A	Flare Traversable LT?	N/A
			N/A	Landing Length (in)	N/A
			N/A	Landing Width (in)	N/A
			N/A	Landing Slope (%)	N/A
			N/A	Landing X Slope (%)	N/A
<p>Surveyor Notes:</p> <p>N/A</p> <p>PROW/ADA:</p> <p>R304.5.1</p>			N/A	Flare Type RT	N/A
			N/A	Flare Slope RT (%)	N/A
			N/A	Flare Traversable RT?	N/A
			N/A	DWS Provided?	N/A
			N/A	DWS Contrast?	N/A
			N/A	DWS Length (in)	N/A
			N/A	DWS Full Width?	N/A
			N/A	DWS Offset (in)	N/A
			N/A	Shared Landing?	N/A
			N/A	Gutter Ponding?	N/A
			N/A	Gutter Lip Ht (in)	N/A
			N/A	Painted X Walk1?	N/A
			Yes	X Walk 1 Direction	N/A
			To NW	X Walk 2 Direction	N/A
			N/A	X Walk 1 Width (in)	N/A

112.0	X Walk 2 Width (in)	N/A
			2.5	X Walk 2 Slope (%)	N/A
			2.2	X Walk 2 X Slope (%)	N/A
			N/A	Ramp inside XWalk1?	N/A
			Yes	Ramp inside XWalk2?	N/A
			N/A	Road Slope (%)	N/A
			N/A	Clear Space?	N/A
			N/A	Clear Space to XWalk (in)	N/A
			N/A	Storm Grate/Utility Hazard?	N/A
			N/A	Storm Grate/Utility Type	N/A
			N/A		N/A
			N/A	Surface Condition? (G/P)	Good
Total Cost:		\$ 1850.00
