Access Compliance Report Public Rights-of-Way (Curb Ramps)

Intersection ID: 15127 Main Street: EXECUTIVE CR Cross Street: REGAL OAKS DR Location: NW ADA ID: FD6B55366229 Ramp Type: Perp Initial Pass/Fail: Fail **Overall Compliance: No Severity Score:** 10

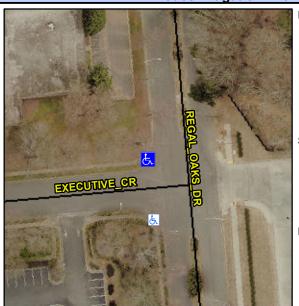
Field Measurements/Component Compilance						
Compliance Description			Data	Compliance Description		Data
N	I/A	Ramp Length (in)	58.0	Yes	Ramp Slope (%)	6.2
N	lo	Ramp Width (in)	47.0	No	Ramp XSlope (%)	4.8
N	I/A	Flare Type LT	N/A	N/A	Flare Type RT	N/A
N	I/A	Flare Slope LT (%)	N/A	N/A	Flare Slope RT (%)	N/A
N	I/A	Flare Traversable LT?	N/A	N/A	Flare Traversable RT?	N/A
N	I/A	Landing Length (in)	N/A	N/A	DWS Provided?	N/A
N	I/A	Landing Width (in)	N/A	N/A	DWS Contrast?	N/A
١	I/A	Landing Slope (%)	N/A	N/A	DWS Length (in)	N/A
N	I/A	Landing X Slope (%)	N/A	N/A	DWS Full Width?	N/A
١	I/A	Landing Curb? (Y/N)	N/A	N/A	DWS Offset (in)	N/A
١	I/A	Shared Landing?	N/A			
١	I/A	Gutter Ponding?	N/A	N/A	Gutter Slope (%)	N/A
N	I/A	Gutter Lip Ht (in)	0.5	N/A	Gutter X Slope (%)	N/A
١	I/A	Painted X Walk1?	No	N/A	Painted X Walk2?	N/A
		X Walk 1 Direction	To S		X Walk 2 Direction	N/A
N	I/A	X Walk 1 Width (in)	N/A	N/A	X Walk 2 Width (in)	N/A

X Walk 1 Slope (%)	0.9		X Walk 2 Slope (%)	N/A
		X Walk 1 X Slope (%)	5.2		X Walk 2 X Slope (%)	N/A
N	I/A	Ramp inside XWalk1?	N/A	N/A	Ramp inside XWalk2?	N/A
		Road Slope (%)	N/A	N/A	Clear Space?	N/A
		Road X Slope (%)	N/A	N/A	Clear Space to XWalk (in)	N/A
١	N/A	Any Obstructions?	N/A	N/A	Storm Grate/Utility Hazard?	N/A
		Obstruction Type			Storm Grate/Utility Type	
			N/A			N/A
				Yes	Surface Condition? (G/P)	Good
_	100000	No. of the second secon

EXECUTIVE CR Street 1 Name Stop Condition-Street 2 StopSign Street 2 Name N/A Stop Condition-Street 1 N/A Possible Solutions: Remove & Replace Entire Ramp. Surveyor Notes: N/A Not Found, R304.5.1, R304.5.3
