Access Compliance Report

Public Rights-of-Way

(Curb Ramps)

Intersection ID: 52624	Main Street: CORMWELL_LN	Cross Street: CONTEMPORARY_PL	Location:	N
ADA ID: FD781DE68FE5	Ramp Type: Perp	Initial Pass/Fail: Fail	Overall Compliance: No	Severity Score: 12.5
Codes/Mitigation Info/Possible Solution		Field Measurements/Component Compliance

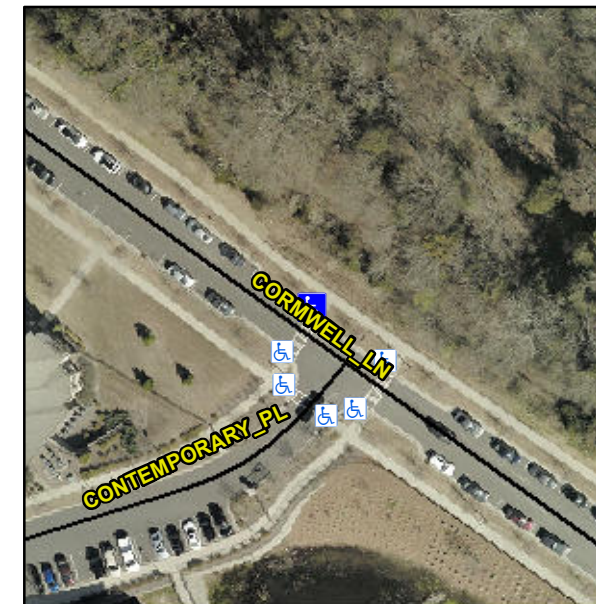
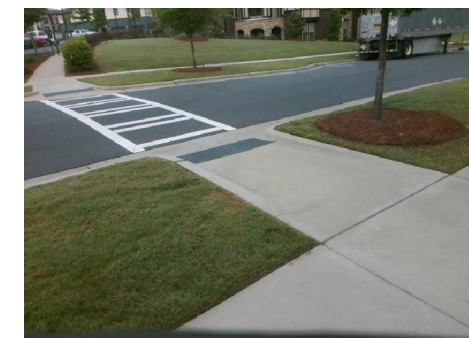
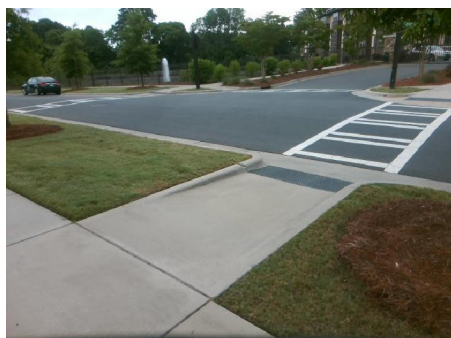
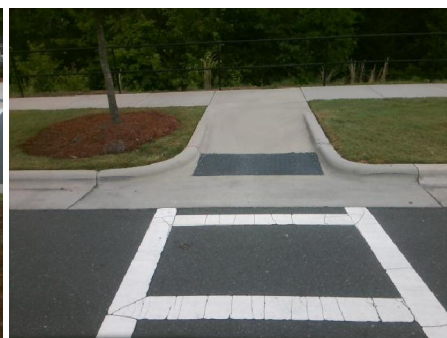
Not Found, R304.2.2

Compliance	Description	Data	Compliance	Description	Data
N/A	Ramp Length (in)	123.0	No	Ramp Slope (%)	10.4
Yes	Ramp Width (in)	60.0	Yes	Ramp XSlope (%)	0.6
N/A	Flare Type LT	N/A	N/A	Flare Type RT	N/A
N/A	Flare Slope LT (%)	N/A	N/A	Flare Slope RT (%)	N/A
N/A	Flare Traversable LT?	N/A	N/A	Flare Traversable RT?	N/A
N/A	Landing Length (in)	N/A	N/A	DWS Provided?	N/A
N/A	Landing Width (in)	N/A	N/A	DWS Contrast?	N/A
N/A	Landing Slope (%)	N/A	N/A	DWS Length (in)	N/A
N/A	Landing X Slope (%)	N/A	N/A	DWS Full Width?	N/A
N/A	Landing Curb? (Y/N)	N/A	N/A	DWS Offset (in)	N/A
N/A	Shared Landing?	N/A			
N/A	Gutter Ponding?	N/A	N/A	Gutter Slope (%)	N/A
N/A	Gutter Lip Ht (in)	N/A	N/A	Gutter X Slope (%)	N/A
N/A	Painted X Walk1?	Yes	N/A	Painted X Walk2?	N/A
	X Walk 1 Direction	To SW		X Walk 2 Direction	N/A
N/A	X Walk 1 Width (in)	62.5	N/A	X Walk 2 Width (in)	N/A
	X Walk 1 Slope (%)	5.4		X Walk 2 Slope (%)	N/A
	X Walk 1 X Slope (%)	0.1		X Walk 2 X Slope (%)	N/A

N/A	Ramp inside XWalk1?	Yes	N/A	Ramp inside XWalk2?	N/A
	Road Slope (%)	N/A	N/A	Clear Space?	N/A
	Road X Slope (%)	N/A	N/A	Clear Space to XWalk (in)	N/A
N/A	Any Obstructions?	N/A	N/A	Storm Grate/Utility Hazard?	N/A
	Obstruction Type			Storm Grate/Utility Type	
		N/A			N/A
			Yes	Surface Condition? (G/P)	Good

Remove & Replace Entire Ramp.
