Access Compliance Report Public Rights-of-Way (Curb Ramps)

Intersection ID: 15102 Main Street: QUEENS_RD Cross Street: E_MOREHEAD_ST Location: N

ADA ID: FD7A2A9FA871 Ramp Type: PerpDiag Initial Pass/Fail: Fail Overall Compliance: No Severity Score: 26.25

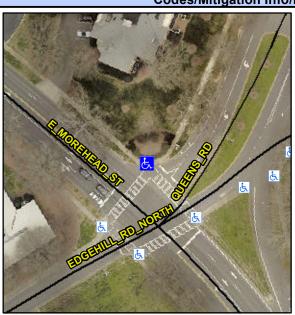
Compliance Description Data		Compliance Description		Data	
N/A	Ramp Length (in)	65.0	No	Ramp Slope (%)	13.4
Yes	Ramp Width (in)	48.0	No	Ramp XSlope (%)	2.4
N/A	Flare Type LT	N/A	N/A	Flare Type RT	N/A
N/A	Flare Slope LT (%)	N/A	N/A	Flare Slope RT (%)	N/A
N/A	Flare Traversable LT?	N/A	N/A	Flare Traversable RT?	N/A
N/A	Landing Length (in)	N/A	N/A	DWS Provided?	N/A
N/A	Landing Width (in)	N/A	N/A	DWS Contrast?	N/A
N/A	Landing Slope (%)	N/A	N/A	DWS Length (in)	N/A
N/A	Landing X Slope (%)	N/A	N/A	DWS Full Width?	N/A
N/A	Landing Curb? (Y/N)	N/A	N/A	DWS Offset (in)	N/A
N/A	Shared Landing?	N/A			
N/A	Gutter Ponding?	N/A	N/A	Gutter Slope (%)	N/A
N/A	Gutter Lip Ht (in)	N/A	N/A	Gutter X Slope (%)	N/A
N/A	Painted X Walk1?	Yes	N/A	Painted X Walk2?	Yes
	X Walk 1 Direction	To SW		X Walk 2 Direction	To SE
N/A	X Walk 1 Width (in)	110.0	N/A	X Walk 2 Width (in)	111.0
	X Walk 1 Slope (%)	3.4		X Walk 2 Slope (%)	3.7
	X Walk 1 X Slope (%)	0.5		X Walk 2 X Slope (%)	2.4

N/A	Ramp inside XWalk1?	Yes	N/A	Ramp inside XWalk2?	Yes
	Road Slope (%)	1.5	N/A	Clear Space?	N/A
	Road X Slope (%)	4.0	N/A	Clear Space to XWalk (in)	N/A
N/A	Any Obstructions?	N/A	N/A	Storm Grate/Utility Hazard?	N/A
	Obstruction Type			Storm Grate/Utility Type	
		N/A			N/A

Remove & Replace Curb Ramp With Two New Directional Ramps or Equivalent.

R304.2.2, R304.5.3
