# Access Compliance Report

## Public Rights-of-Way

### (Curb Ramps)

| Intersection ID: N/A | Main Street: BERTONLEY_AV | Cross Street: WATER_OAK_RD | Location: SW |

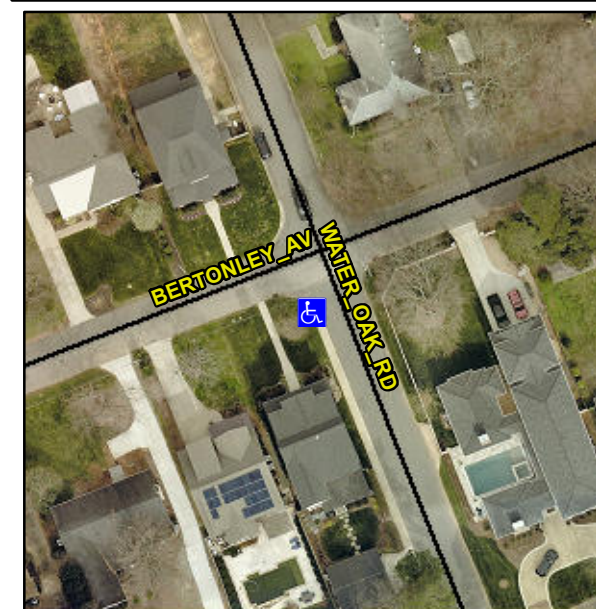
| ADA ID: FD846F51E553 | Ramp Type: Directional2 | Initial Pass/Fail: Fail | Overall Compliance: No |
| Severity Score: 22.5 | | | |

**R304.5.1, R304.2.2, R304.5.3**

| Compliance | Description | Data | Compliance | Description | Data |
|---|---|---|---|---|---|
| No | Ramp Width (in) | 37.5 | N/A | Grade Break Slope (%) | 0.0 |
| No | Ramp Slope (%) | 9.5 | N/A | Grade Break XSlope (%) | 0.0 |
| No | Ramp XSlope (%) | 3.6 | | | |

**Remove & Replace Entire Ramp.**

Total Cost: \$ 1800.00
