Access Compliance Report

Public Rights-of-Way

(Curb Ramps)

Intersection ID: 27531	Main Street: BALLANTYNE COMMONS PY	Cross Street: PLANTATION PARK BV	Location:	E
ADA ID: FD8473A48D96	Ramp Type: Perp	Initial Pass/Fail: Fail	Overall Compliance: No	Severity Score: 25
Codes/Mitigation Info/Possible Solution		Field Measurements/Component Compliance

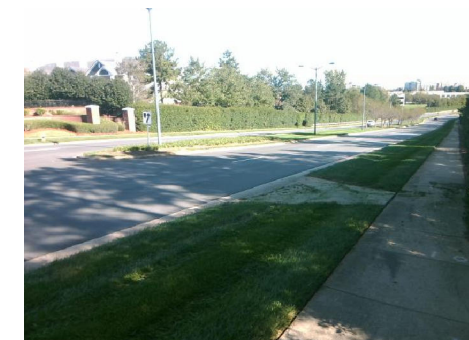
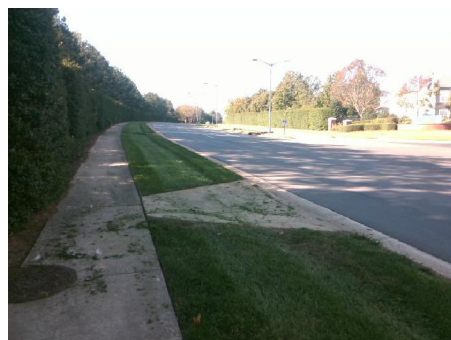
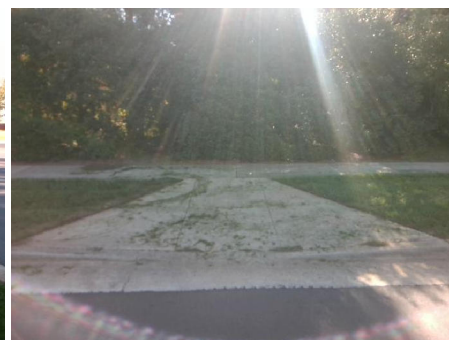
Not Found, R304.5.3

Compliance	Description	Data	Compliance	Description	Data
N/A	Ramp Length (in)	118.0	Yes	Ramp Slope (%)	7.9
Yes	Ramp Width (in)	48.0	No	Ramp XSlope (%)	10.8
N/A	Flare Type LT	N/A	N/A	Flare Type RT	N/A
N/A	Flare Slope LT (%)	N/A	N/A	Flare Slope RT (%)	N/A
N/A	Flare Traversable LT?	N/A	N/A	Flare Traversable RT?	N/A
N/A	Landing Length (in)	N/A	N/A	DWS Provided?	N/A
N/A	Landing Width (in)	N/A	N/A	DWS Contrast?	N/A
N/A	Landing Slope (%)	N/A	N/A	DWS Length (in)	N/A
N/A	Landing X Slope (%)	N/A	N/A	DWS Full Width?	N/A
N/A	Landing Curb? (Y/N)	N/A	N/A	DWS Offset (in)	N/A
N/A	Shared Landing?	N/A			
N/A	Gutter Ponding?	N/A	N/A	Gutter Slope (%)	N/A
N/A	Gutter Lip Ht (in)	N/A	N/A	Gutter X Slope (%)	N/A
N/A	Painted X Walk1?	No	N/A	Painted X Walk2?	N/A
	X Walk 1 Direction	To NW		X Walk 2 Direction	N/A
N/A	X Walk 1 Width (in)	N/A	N/A	X Walk 2 Width (in)	N/A
	X Walk 1 Slope (%)	2.1		X Walk 2 Slope (%)	N/A
	X Walk 1 X Slope (%)	7.4		X Walk 2 X Slope (%)	N/A

N/A	Ramp inside XWalk1?	N/A	N/A	Ramp inside XWalk2?	N/A
	Road Slope (%)	N/A	N/A	Clear Space?	N/A
	Road X Slope (%)	N/A	N/A	Clear Space to XWalk (in)	N/A
N/A	Any Obstructions?	N/A	N/A	Storm Grate/Utility Hazard?	N/A
	Obstruction Type			Storm Grate/Utility Type	
		N/A			N/A
			Yes	Surface Condition? (G/P)	Good

Remove & Replace Entire Ramp.
