# Access Compliance Report

## Public Rights-of-Way

### (Curb Ramps)

| Intersection ID: 27906 | Main Street: BALLANTYNE COUNTRY CLUB DR | Cross Street: HARRISON'S CROSSING AV | Location: SW |

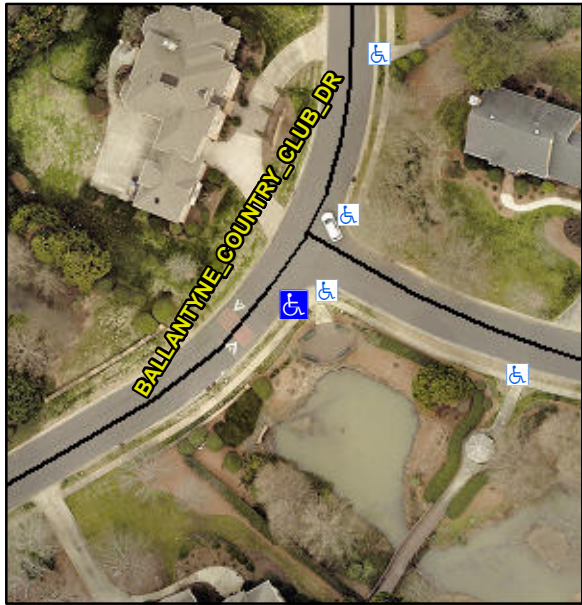
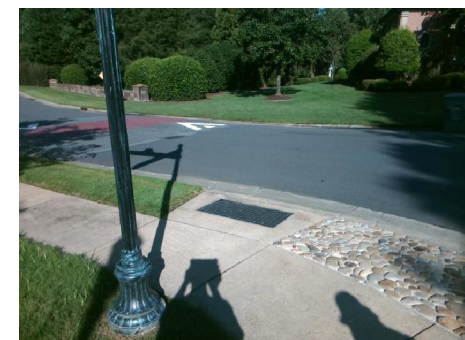
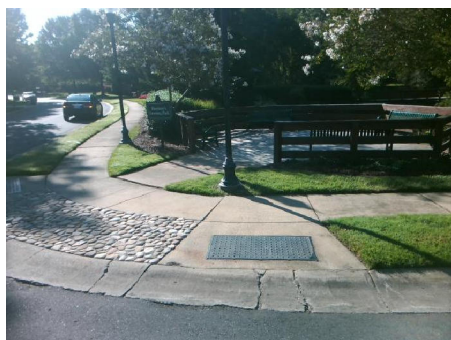
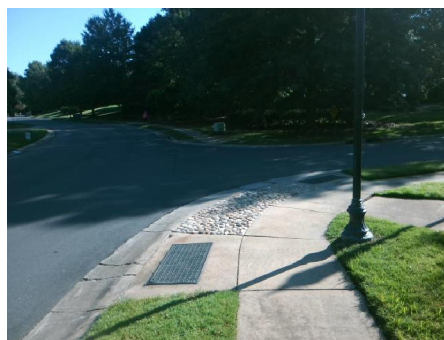
| ADA ID: FD896599D6E3 | Ramp Type: BlendTrans2 | Initial Pass/Fail: Fail | Overall Compliance: No |

| Severity Score: 12.5 | | | |

Not Found, R304.5.3

| Compliance | Description | Data | Compliance | Description | Data |
|---|---|---|---|---|---|
| Yes | Ramp Width (in) | 48.0 | No | BlendTrans XSlope (%) | 6.2 |
| | | | No | Curb Slope (%) | 15.0 |

Remove & Replace Curb Ramp With Two New Directional Ramps or Equivalent.

3200.00
