Access Compliance Report

Public Rights-of-Way

(Curb Ramps)

Intersection ID: 49275	Main Street: GATHERING_CT	Cross Street: REUNION_ST	Location: NE
ADA ID: FD9D74895ED0	Ramp Type: PerpDiag	Initial Pass/Fail: Fail	Overall Compliance: No
Severity Score: 10			
Codes/Mitigation Info/Possible Solution		Field Measurements/Component Compliance

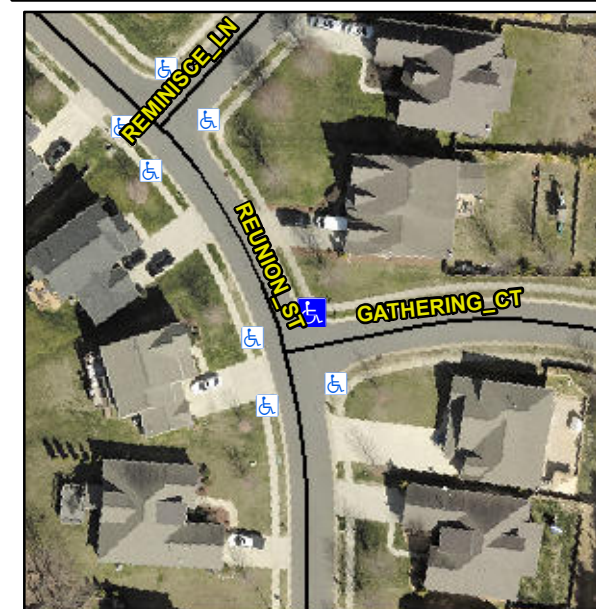
PROW/ADA:

Not Found, R304.5.1, R304.5.3

Compliance	Description	Data	Compliance	Description	Data
N/A	Ramp Length (in)	47.0	Yes	Ramp Slope (%)	5.2
No	Ramp Width (in)	47.0	No	Ramp XSlope (%)	4.4
N/A	Flare Type LT	N/A	N/A	Flare Type RT	N/A
N/A	Flare Slope LT (%)	N/A	N/A	Flare Slope RT (%)	N/A
N/A	Flare Traversable LT?	N/A	N/A	Flare Traversable RT?	N/A
N/A	Landing Length (in)	N/A	N/A	DWS Provided?	N/A
N/A	Landing Width (in)	N/A	N/A	DWS Contrast?	N/A
N/A	Landing Slope (%)	N/A	N/A	DWS Length (in)	N/A
N/A	Landing X Slope (%)	N/A	N/A	DWS Full Width?	N/A
N/A	Landing Curb? (Y/N)	N/A	N/A	DWS Offset (in)	N/A
N/A	Shared Landing?	N/A			
N/A	Gutter Ponding?	N/A	N/A	Gutter Slope (%)	N/A
N/A	Gutter Lip Ht (in)	N/A	N/A	Gutter X Slope (%)	N/A
N/A	Painted X Walk1?	No	N/A	Painted X Walk2?	No
	X Walk 1 Direction	To W		X Walk 2 Direction	To S
N/A	X Walk 1 Width (in)	N/A	N/A	X Walk 2 Width (in)	N/A
	X Walk 1 Slope (%)	2.1		X Walk 2 Slope (%)	3.9
	X Walk 1 X Slope (%)	4.5		X Walk 2 X Slope (%)	2.3

N/A	Ramp inside XWalk1?	N/A	N/A	Ramp inside XWalk2?	N/A
	Road Slope (%)	3.5	N/A	Clear Space?	N/A
	Road X Slope (%)	4.8	N/A	Clear Space to XWalk (in)	N/A
N/A	Any Obstructions?	N/A	N/A	Storm Grate/Utility Hazard?	N/A
	Obstruction Type			Storm Grate/Utility Type	
		N/A			N/A
		Yes		Surface Condition? (G/P)	Good

Possible Solutions:

Remove & Replace Curb Ramp With Two New Directional Ramps or Equivalent.
