Access Compliance Report Public Rights-of-Way (Curb Ramps)

Intersection ID: 11543 Main Street: GRACE_ST Cross Street: LOLA_AV Location: SW

ADA ID: FDA7AE301A14 Ramp Type: Perp Initial Pass/Fail: Fail Overall Compliance: No Severity Score: 8.75

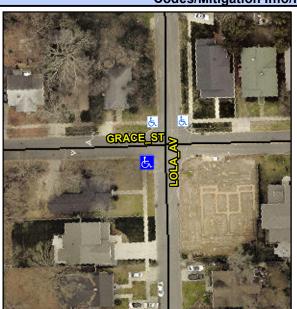
o/Possible Solution	Field Measurements/Component Compliance						
Possible Solutions:	Comp	liance Description	Data	Compli	ance	Description	
Remove & Replace Entire Ramp.	N/A	Ramp Length (in)	83.0	Yes	Ramp	Slope (%)	
	No	Ramp Width (in)	47.0	Yes	Ramp	XSlope (%)	
	N/A	Flare Type LT	N/A	N/A	Flare	Type RT	
	N/A	Flare Slope LT (%)	N/A	N/A	Flare	Slope RT (%)	
	N/A	Flare Traversable LT?	N/A	N/A	Flare	Traversable RT?

-	N/A	Landing Length (in)	N/A	N/A	DWS	Provided?	
Surveyor Notes:	N/A	Landing Width (in)	N/A	N/A	DWS	Contrast?	
N/A	N/A	Landing Slope (%)	N/A	N/A	DWS	Length (in)	
	N/A	Landing X Slope (%)	N/A	N/A	DWS	Full Width?	
	N/A	Landing Curb? (Y/N)	N/A	N/A	DWS	Offset (in)	
	N/A	Shared Landing?	N/A				
PROW/ADA:	N/A	Gutter Ponding?	N/A	N/A	Gutte	r Slope (%)	
Not Found, R304.5.1	N/A	Gutter Lip Ht (in)	0.75	N/A	Gutte	r X Slope (%)	
	N/A	Painted X Walk1?	No	N/A	Painte	ed X Walk2?	
		X Walk 1 Direction	To N		X Wa	lk 2 Direction	
	N/A	X Walk 1 Width (in)	N/A	N/A	X Wa	lk 2 Width (in)	
		X Walk 1 Slope (%)	2.8		X Wa	lk 2 Slope (%)	
		X Walk 1 X Slope (%)	1.4		X Wa	lk 2 X Slope (%)	
	N/A	Ramp inside XWalk1?	N/A	N/A	Ramp	inside XWalk2?	
		Road Slope (%)	N/A	N/A	Clear	Space?	
		Road X Slope (%)	N/A	N/A	Clear	Space to XWalk (in)	
	N/A	Any Obstructions?	N/A	N/A	Storm	Grate/Utility Hazard?	
Total Cost: \$ 1850.00		Obstruction Type		l	Storm	Grate/Utility Type
