Access Compliance Report Public Rights-of-Way (Curb Ramps)

Intersection ID: N/A Main Street: DURANT BV **Cross Street: N/A** Location:

ADA ID: FDABFABD66E5 Ramp Type: PerpDiag Initial Pass/Fail: Fail **Overall Compliance: No** Severity Score: 46.25

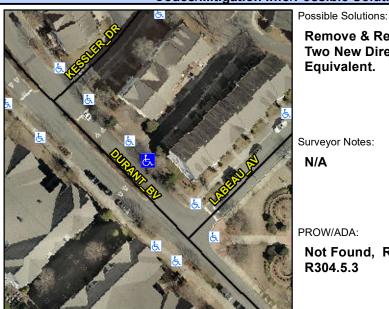
Not Found, R304.5.1, R304.2.2, R304.5.3

Compliance Description Data		Comp	oliance Description	Data	
N/A	Ramp Length (in)	125.0	No	Ramp Slope (%)	11.3
No	Ramp Width (in)	46.0	No	Ramp XSlope (%)	7.2
N/A	Flare Type LT	N/A	N/A	Flare Type RT	N/A
N/A	Flare Slope LT (%)	N/A	N/A	Flare Slope RT (%)	N/A
N/A	Flare Traversable LT?	N/A	N/A	Flare Traversable RT?	N/A
N/A	Landing Length (in)	N/A	N/A	DWS Provided?	N/A
N/A	Landing Width (in)	N/A	N/A	DWS Contrast?	N/A
N/A	Landing Slope (%)	N/A	N/A	DWS Length (in)	N/A
N/A	Landing X Slope (%)	N/A	N/A	DWS Full Width?	N/A
N/A	Landing Curb? (Y/N)	N/A	N/A	DWS Offset (in)	N/A
N/A	Shared Landing?	N/A			
N/A	Gutter Ponding?	N/A	N/A	Gutter Slope (%)	N/A
N/A	Gutter Lip Ht (in)	N/A	N/A	Gutter X Slope (%)	N/A
N/A	Painted X Walk1?	No	N/A	Painted X Walk2?	No
	X Walk 1 Direction	To NW		X Walk 2 Direction	To W
N/A	X Walk 1 Width (in)	N/A	N/A	X Walk 2 Width (in)	N/A
	X Walk 1 Slope (%)	1.9		X Walk 2 Slope (%)	3.6
	X Walk 1 X Slope (%)	4.2		X Walk 2 X Slope (%)	4.4

N/A	Ramp inside XWalk1?	N/A	N/A	Ramp inside XWalk2?	N/A
	Road Slope (%)	7.1	N/A	Clear Space?	N/A
	Road X Slope (%)	0.2	N/A	Clear Space to XWalk (in)	N/A
N/A	Any Obstructions?	N/A	N/A	Storm Grate/Utility Hazard?	N/A
	Obstruction Type		l	Storm Grate/Utility Type	
		N/A			N/A
			Yes	Surface Condition? (G/P)	Good

Remove & Replace Curb Ramp With **Two New Directional Ramps or** Equivalent.
