Access Compliance Report

Public Rights-of-Way

(Curb Ramps)

Intersection ID: 43119	Main Street: BELLE_TERRE_AV	Cross Street: THOMAS_AV	Location: NW
ADA ID: FDB61FEEDEC8	Ramp Type: Directional1	Initial Pass/Fail: Fail	Overall Compliance: No
		Severity Score: 1.25

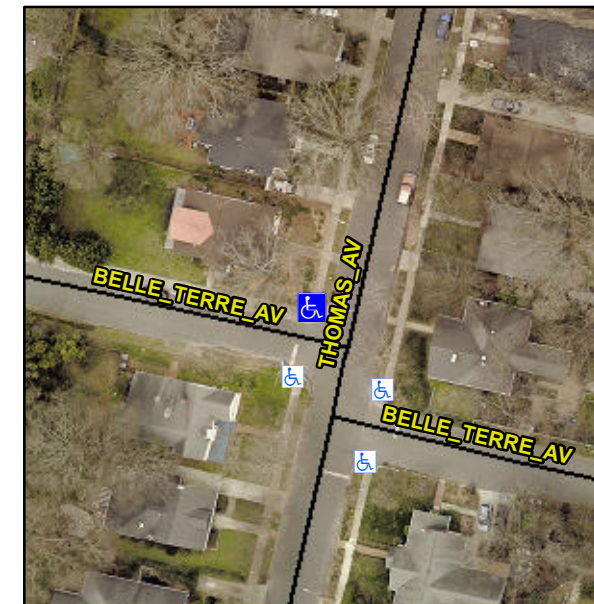
Compliance	Description	Data	Compliance	Description	Data
N/A	Ramp Length (in)	71.0	N/A	Grade Break?	N/A
Yes	Ramp Width (in)	60.0	N/A	Grade Break Slope (%)	0.0
Yes	Ramp Slope (%)	5.0	N/A	Grade Break XSlope (%)	0.0
No	Ramp XSlope (%)	3.3			
N/A	Flare Type LT	N/A	N/A	Flare Type RT	N/A
N/A	Flare Slope LT (%)	N/A	N/A	Flare Slope RT (%)	0.0
N/A	Flare Traversable LT?	N/A	N/A	Flare Traversable RT?	N/A
N/A	Landing Length (in)	0.0	N/A	DWS Provided?	N/A
N/A	Landing Width (in)	0.0	N/A	DWS Contrast?	N/A
N/A	Landing Slope (%)	0.0	N/A	DWS Length (in)	N/A
N/A	Landing X Slope (%)	0.0	N/A	DWS Full Width?	N/A
N/A	Landing Curb? (Y/N)	N/A	N/A	DWS Offset LT (in)	N/A
N/A	Shared Landing?	N/A	N/A	DWS Offset RT (in)	N/A
N/A	Gutter Ponding?	0.0	N/A	Gutter Slope (%)	N/A
N/A	Gutter Lip Ht (in)	0.0	N/A	Gutter X Slope (%)	N/A
N/A	Painted X Walk1?	No		Road Slope (%)	2.9
	X Walk 1 Direction	To S		Road X Slope (%)	0.9
	X Walk 1 Width (in)	N/A		Clear Space?	N/A

X Walk 1 Slope (%)	2.9	N/A	Clear Space to XWalk (in)	N/A
	X Walk 1 X Slope (%)	0.9	N/A	Storm Grate/Utility Hazard?	N/A
N/A	Ramp inside XWalk1?	N/A		Storm Grate/Utility Type	
N/A	Any Obstructions?	N/A			N/A
	Obstruction Type		Yes	Surface Condition? (G/P)	Good
			N/A	Curb Slope (%)	10.8

Remove & Replace Entire Ramp.
