# Access Compliance Report

## Public Rights-of-Way

### (Curb Ramps)

| Intersection ID: 27452 | Main Street: BALLANTYNE_COMMONS_PY | Cross Street: BALLANTYNE_CORPORATE_PL | Location: NW |

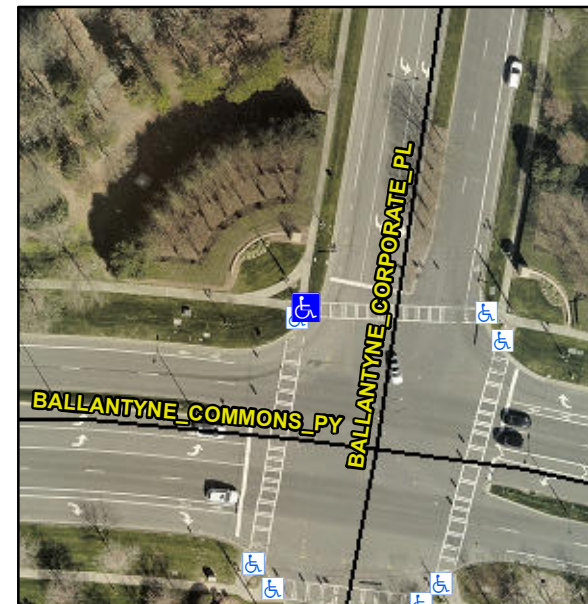
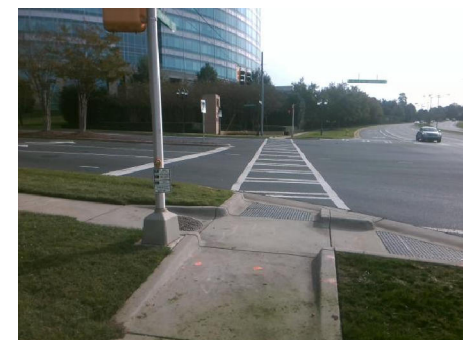
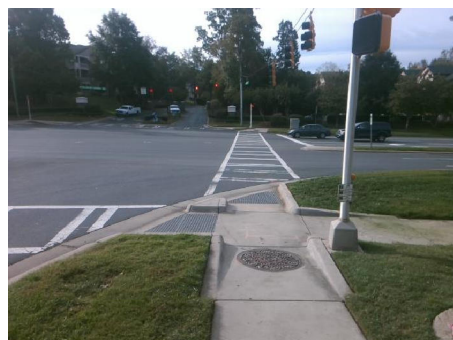
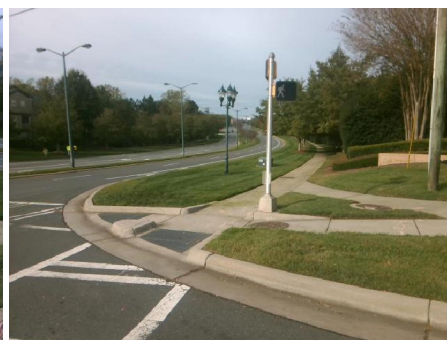
**R304.2.2-Perp, R304.3.2-Para,  
R304.5.3, R305.1.4**

| Compliance | Description | Data | Compliance | Description | Data |
|---|---|---|---|---|---|
| No | Landing Slope (%) | 2.4 | Yes | DWS Length (in) | 26.0 |
| No | Landing X Slope (%) | 3.0 | No | DWS Full Width? | No |
| Yes | Gutter Lip Ht (in) | 0.0 | No | Gutter X Slope (%) | 4.6 |

**Remove & Replace Entire Ramp.  
Remove & Replace Gutter.**
