# Access Compliance Report

## Public Rights-of-Way

### (Curb Ramps)

Intersection ID: 10036288	Main Street: ROSE_RIDGE_PL	Cross Street: N/A	Location: NE
ADA ID: FDFC946B99D5	Ramp Type: Perp	Initial Pass/Fail: Fail	Overall Compliance: No
Severity Score: 13.75			
Codes/Mitigation Info/Possible Solution		Field Measurements/Component Compliance

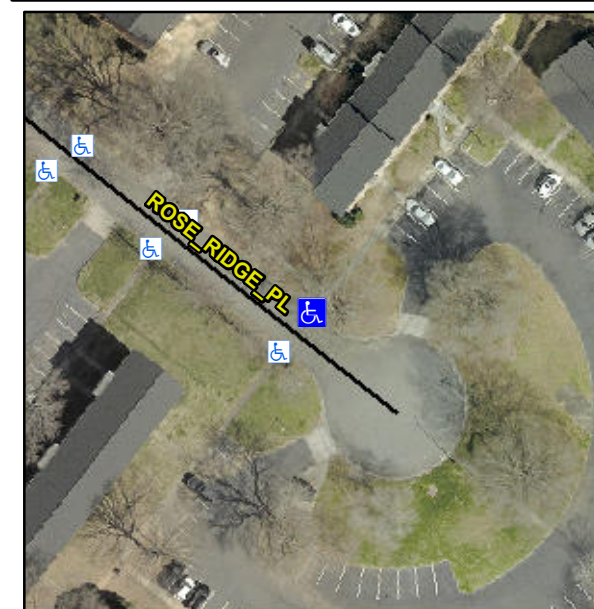
**Not Found, R304.2.2**

Compliance	Description	Data	Compliance	Description	Data
N/A	Ramp Length (in)	43.0	No	Ramp Slope (%)	11.7
Yes	Ramp Width (in)	48.0	Yes	Ramp XSlope (%)	2.7
N/A	Flare Type LT	N/A	N/A	Flare Type RT	N/A
N/A	Flare Slope LT (%)	N/A	N/A	Flare Slope RT (%)	N/A
N/A	Flare Traversable LT?	N/A	N/A	Flare Traversable RT?	N/A
N/A	Landing Length (in)	N/A	N/A	DWS Provided?	N/A
N/A	Landing Width (in)	N/A	N/A	DWS Contrast?	N/A
N/A	Landing Slope (%)	N/A	N/A	DWS Length (in)	N/A
N/A	Landing X Slope (%)	N/A	N/A	DWS Full Width?	N/A
N/A	Landing Curb? (Y/N)	N/A	N/A	DWS Offset (in)	N/A
N/A	Shared Landing?	N/A			
N/A	Gutter Ponding?	N/A	N/A	Gutter Slope (%)	N/A
N/A	Gutter Lip Ht (in)	2.0	N/A	Gutter X Slope (%)	N/A
N/A	Painted X Walk1?	No	N/A	Painted X Walk2?	N/A
	X Walk 1 Direction	To SW		X Walk 2 Direction	N/A
N/A	X Walk 1 Width (in)	N/A	N/A	X Walk 2 Width (in)	N/A
	X Walk 1 Slope (%)	5.0		X Walk 2 Slope (%)	N/A
	X Walk 1 X Slope (%)	3.3		X Walk 2 X Slope (%)	N/A

N/A	Ramp inside XWalk1?	N/A	N/A	Ramp inside XWalk2?	N/A
	Road Slope (%)	N/A	N/A	Clear Space?	N/A
	Road X Slope (%)	N/A	N/A	Clear Space to XWalk (in)	N/A
N/A	Any Obstructions?	N/A	N/A	Storm Grate/Utility Hazard?	N/A
	Obstruction Type			Storm Grate/Utility Type	
		N/A			N/A
			Yes	Surface Condition? (G/P)	Good

Possible Solutions:

**Remove & Replace Entire Ramp.**

Total Cost: \$ 1850.00
