## Access Compliance Report Public Rights-of-Way (Curb Ramps)

Intersection ID: 44723 Main Street: PROSPERITY\_CHURCH\_RD Cross Street: JOHNSTON\_OEHLER\_RD Location: NW

ADA ID: FE2150F73B7C Ramp Type: Perp Initial Pass/Fail: Fail Overall Compliance: No Severity Score: 21.25

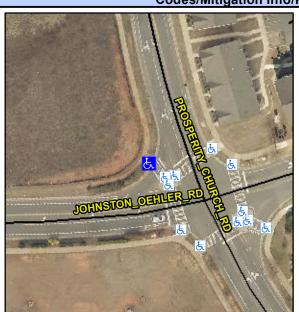
R304.5.1, R304.2.2

| Field Measurements/Component Compilance | | | | | |
|---|---|---|---|---|---|
| N/A | Ramp Length (in) | 94.0 | No | Ramp Slope (%) | 10.0 |
| No | Ramp Width (in) | 42.0 | Yes | Ramp XSlope (%) | 0.2 |

Remove & Replace Entire Ramp.

Total Cost: \$ 1850.00
