# Access Compliance Report

## Public Rights-of-Way

| Intersection ID: 10024053 | Main Street: CORONATION_BV | Cross Street: N/A | Location: NE |
| ADA ID: FE349C5CA5BC | Ramp Type: PerpDiag | Initial Pass/Fail: Fail | Overall Compliance: No |

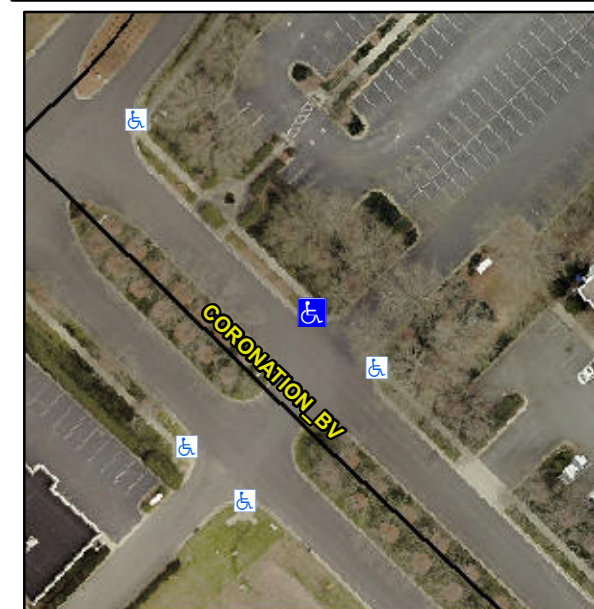
**Not Found, R304.2.2, R304.5.3**

| Compliance | Description | Data | Compliance | Description | Data |
|---|---|---|---|---|---|
| N/A | Ramp Length (in) | 78.0 | No | Ramp Slope (%) | 8.6 |
| Yes | Ramp Width (in) | 48.0 | No | Ramp XSlope (%) | 3.3 |

**Remove & Replace Curb Ramp With Two New Directional Ramps or Equivalent.**

Total Cost: \$ 3200.00
