Access Compliance Report

Public Rights-of-Way

(Curb Ramps)

Intersection ID: N/A	Main Street: CANTERBURY CASTLE DR	Cross Street: BELVEDERE CASTLE DR	Location: SE
ADA ID: FE4CEA4CBD82	Ramp Type: Perp	Initial Pass/Fail: Fail	Overall Compliance: No
Severity Score: 12.5			
Codes/Mitigation Info/Possible Solution		Field Measurements/Component Compliance

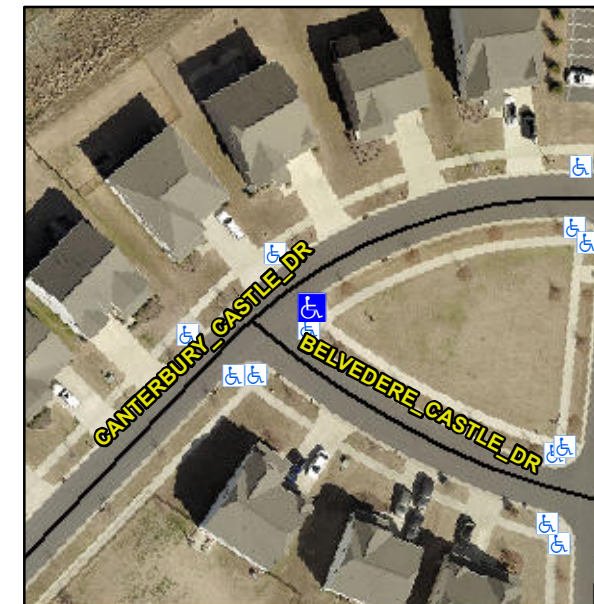
Compliance	Description	Data	Compliance	Description	Data
N/A	Ramp Length (in)	97.0	No	Ramp Slope (%)	8.4
Yes	Ramp Width (in)	48.0	Yes	Ramp XSlope (%)	0.5
N/A	Flare Type LT	N/A	N/A	Flare Type RT	N/A
N/A	Flare Slope LT (%)	N/A	N/A	Flare Slope RT (%)	N/A
N/A	Flare Traversable LT?	N/A	N/A	Flare Traversable RT?	N/A
N/A	Landing Length (in)	N/A	N/A	DWS Provided?	N/A
N/A	Landing Width (in)	N/A	N/A	DWS Contrast?	N/A
N/A	Landing Slope (%)	N/A	N/A	DWS Length (in)	N/A
N/A	Landing X Slope (%)	N/A	N/A	DWS Full Width?	N/A
N/A	Landing Curb? (Y/N)	N/A	N/A	DWS Offset (in)	N/A
N/A	Shared Landing?	N/A			
N/A	Gutter Ponding?	N/A	N/A	Gutter Slope (%)	N/A
N/A	Gutter Lip Ht (in)	N/A	N/A	Gutter X Slope (%)	N/A
N/A	Painted X Walk1?	No	N/A	Painted X Walk2?	N/A
	X Walk 1 Direction	To NW		X Walk 2 Direction	N/A
N/A	X Walk 1 Width (in)	N/A	N/A	X Walk 2 Width (in)	N/A
	X Walk 1 Slope (%)	1.2		X Walk 2 Slope (%)	N/A
	X Walk 1 X Slope (%)	1.4		X Walk 2 X Slope (%)	N/A

Possible Solutions:

Remove & Replace Entire Ramp.

R304.2.2

\$ 1850.00
