Access Compliance Report

Public Rights-of-Way

(Curb Ramps)

Intersection ID: 17467	Main Street: CROYDON_RD	Cross Street: STERLING_RD	Location: SW
ADA ID: FE546A585AA8	Ramp Type: PerpDiag	Initial Pass/Fail: Fail	Overall Compliance: No
Severity Score: 12.5			
Codes/Mitigation Info/Possible Solution		Field Measurements/Component Compliance

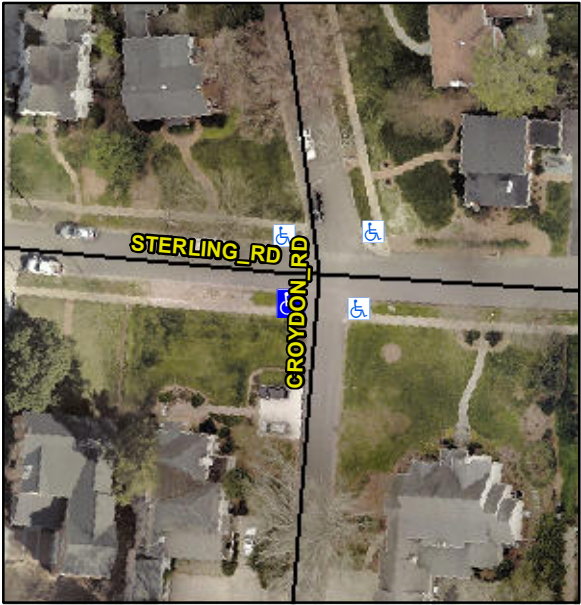
Possible Solutions:		Compliance	Description	Data	Compliance	Description	Data
	Remove & Replace Curb Ramp With Two New Directional Ramps or Equivalent.		N/A	Ramp Length (in)	85.0	Yes	Ramp Slope (%)	6.5
<p>Surveyor Notes:</p> <p>N/A</p> <p>PROW/ADA:</p> <p>R304.5.3</p>			Yes	Ramp Width (in)	50.0	No	Ramp XSlope (%)	5.6
			N/A	Flare Type LT	N/A	N/A	Flare Type RT	N/A
			N/A	Flare Slope LT (%)	N/A	N/A	Flare Slope RT (%)	N/A
			N/A	Flare Traversable LT?	N/A	N/A	Flare Traversable RT?	N/A
			N/A	Landing Length (in)	N/A	N/A	DWS Provided?	N/A
			N/A	Landing Width (in)	N/A	N/A	DWS Contrast?	N/A
			N/A	Landing Slope (%)	N/A	N/A	DWS Length (in)	N/A
			N/A	Landing X Slope (%)	N/A	N/A	DWS Full Width?	N/A
			N/A	Landing Curb? (Y/N)	N/A	N/A	DWS Offset (in)	N/A
			N/A	Shared Landing?	N/A			
			N/A	Gutter Ponding?	N/A	N/A	Gutter Slope (%)	N/A
			N/A	Gutter Lip Ht (in)	N/A	N/A	Gutter X Slope (%)	N/A
			N/A	Painted X Walk1?	No	N/A	Painted X Walk2?	No

X Walk 1 Direction	To SE		X Walk 2 Direction	To N
			N/A	X Walk 1 Width (in)	N/A	N/A	X Walk 2 Width (in)	N/A
				X Walk 1 Slope (%)	6.8		X Walk 2 Slope (%)	4.2
				X Walk 1 X Slope (%)	1.3		X Walk 2 X Slope (%)	6.9
			N/A	Ramp inside XWalk1?	N/A	N/A	Ramp inside XWalk2?	N/A
				Road Slope (%)	3.0	N/A	Clear Space?	N/A
				Road X Slope (%)	6.4	N/A	Clear Space to XWalk (in)	N/A
			N/A	Any Obstructions?	N/A	N/A	Storm Grate/Utility Hazard?	N/A
				Obstruction Type			Storm Grate/Utility Type	
						N/A		N/A
						Yes	Surface Condition? (G/P)	Good
Total Cost:		\$ 3200.00
