# Access Compliance Report

## Public Rights-of-Way

### (Curb Ramps)

Intersection ID: 46575	Main Street: ATKINS_CIRCLE_DR	Cross Street: JOHNSTON_RD	Location: NW
ADA ID: FE566B239EC9	Ramp Type: PerpDiag	Initial Pass/Fail: Fail	Overall Compliance: No
Codes/Mitigation Info/Possible Solution		Field Measurements/Component Compliance	
Severity Score: 8.75

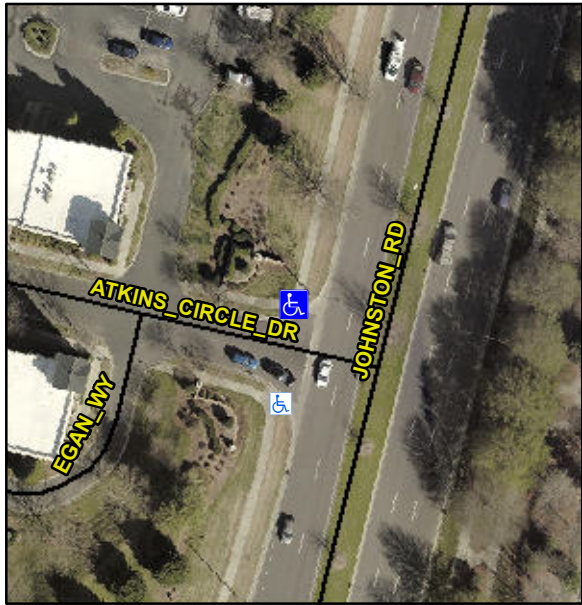
Compliance	Description	Data	Compliance	Description	Data
N/A	Ramp Length (in)	55.0	Yes	Ramp Slope (%)	5.1
No	Ramp Width (in)	40.0	Yes	Ramp XSlope (%)	1.6
N/A	Flare Type LT	N/A	N/A	Flare Type RT	N/A
N/A	Flare Slope LT (%)	N/A	N/A	Flare Slope RT (%)	N/A
N/A	Flare Traversable LT?	N/A	N/A	Flare Traversable RT?	N/A
N/A	Landing Length (in)	N/A	N/A	DWS Provided?	N/A
N/A	Landing Width (in)	N/A	N/A	DWS Contrast?	N/A
N/A	Landing Slope (%)	N/A	N/A	DWS Length (in)	N/A
N/A	Landing X Slope (%)	N/A	N/A	DWS Full Width?	N/A
N/A	Landing Curb? (Y/N)	N/A	N/A	DWS Offset (in)	N/A
N/A	Shared Landing?	N/A			
N/A	Gutter Ponding?	N/A	N/A	Gutter Slope (%)	N/A
N/A	Gutter Lip Ht (in)	N/A	N/A	Gutter X Slope (%)	N/A
N/A	Painted X Walk1?	No	N/A	Painted X Walk2?	No
	X Walk 1 Direction	To SW		X Walk 2 Direction	To SE
N/A	X Walk 1 Width (in)	N/A	N/A	X Walk 2 Width (in)	N/A
	X Walk 1 Slope (%)	3.4		X Walk 2 Slope (%)	3.8
	X Walk 1 X Slope (%)	6.1		X Walk 2 X Slope (%)	3.0

N/A	Ramp inside XWalk1?	N/A	N/A	Ramp inside XWalk2?	N/A
	Road Slope (%)	2.2	N/A	Clear Space?	N/A
	Road X Slope (%)	5.8	N/A	Clear Space to XWalk (in)	N/A
N/A	Any Obstructions?	N/A	N/A	Storm Grate/Utility Hazard?	N/A
	Obstruction Type			Storm Grate/Utility Type	
		N/A			N/A
			Yes	Surface Condition? (G/P)	Good

Possible Solutions:

Remove & Replace Curb Ramp With Two New Directional Ramps or Equivalent.
