# Access Compliance Report

## Public Rights-of-Way

### (Curb Ramps)

Intersection ID: N/A	Main Street: INVERNESS_BAY_RD	Cross Street: ELGIN_MOOR_RD	Location: SW
ADA ID: FE6A07E0574D	Ramp Type: Perp	Initial Pass/Fail: Fail	Overall Compliance: No
		Severity Score: 10

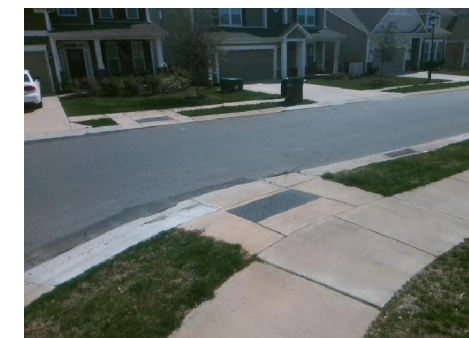
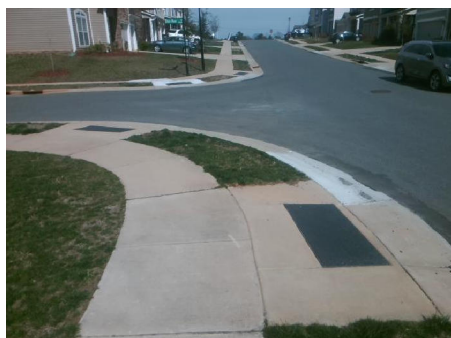
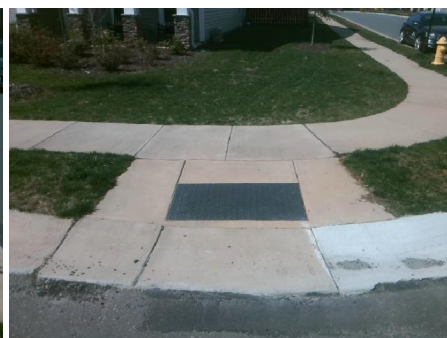
**Not Found, R304.5.1**

Compliance	Description	Data	Compliance	Description	Data
N/A	Ramp Length (in)	48.0	Yes	Ramp Slope (%)	5.1
No	Ramp Width (in)	47.0	Yes	Ramp XSlope (%)	2.3
N/A	Flare Type LT	N/A	N/A	Flare Type RT	N/A
N/A	Flare Slope LT (%)	N/A	N/A	Flare Slope RT (%)	N/A
N/A	Flare Traversable LT?	N/A	N/A	Flare Traversable RT?	N/A
N/A	Landing Length (in)	N/A	N/A	DWS Provided?	N/A
N/A	Landing Width (in)	N/A	N/A	DWS Contrast?	N/A
N/A	Landing Slope (%)	N/A	N/A	DWS Length (in)	N/A
N/A	Landing X Slope (%)	N/A	N/A	DWS Full Width?	N/A
N/A	Landing Curb? (Y/N)	N/A	N/A	DWS Offset (in)	N/A
N/A	Shared Landing?	N/A			
N/A	Gutter Ponding?	N/A	N/A	Gutter Slope (%)	N/A
N/A	Gutter Lip Ht (in)	1.0	N/A	Gutter X Slope (%)	N/A
N/A	Painted X Walk1?	No	N/A	Painted X Walk2?	N/A
	X Walk 1 Direction	To SE		X Walk 2 Direction	N/A
N/A	X Walk 1 Width (in)	N/A	N/A	X Walk 2 Width (in)	N/A
	X Walk 1 Slope (%)	0.2		X Walk 2 Slope (%)	N/A
	X Walk 1 X Slope (%)	2.3		X Walk 2 X Slope (%)	N/A

N/A	Ramp inside XWalk1?	N/A	N/A	Ramp inside XWalk2?	N/A
	Road Slope (%)	N/A	N/A	Clear Space?	N/A
	Road X Slope (%)	N/A	N/A	Clear Space to XWalk (in)	N/A
N/A	Any Obstructions?	N/A	N/A	Storm Grate/Utility Hazard?	N/A
	Obstruction Type			Storm Grate/Utility Type	
		N/A			N/A
			Yes	Surface Condition? (G/P)	Good

**Remove & Replace Entire Ramp.**

Total Cost: \$ 1850.00
