Access Compliance Report Public Rights-of-Way (Curb Ramps)

Intersection ID: 12222 Main Street: W_MOREHEAD_ST Cro					ss Street: S_CLARKSON_ST				W
ADA ID: FE6DB28CE1C8	BCE1C8 Ramp Type: PerpDiag			nitial Pass/Fail: Fail Overall Compliance: No				o Severity Score:	12.5
Codes/Mitigation Info/Possible Solution				Field Measurements/Component Compliance					
	at the state of the	Possible Solutions:		Compliance Description			Data Compliance Description		
The second second	The second second	Remove & Replace Curb Ramp V	Vith	N/A	Ramp Length (in)	104.0	Yes	Ramp Slope (%)	8.1
		Two New Directional Ramps or Equivalent.		Yes	Ramp Width (in)	58.0	No	Ramp XSlope (%)	5.2
The second is	State State			N/A	Flare Type LT	N/A	N/A	Flare Type RT	N/A
				N/A	Flare Slope LT (%)	N/A	N/A	Flare Slope RT (%)	N/A

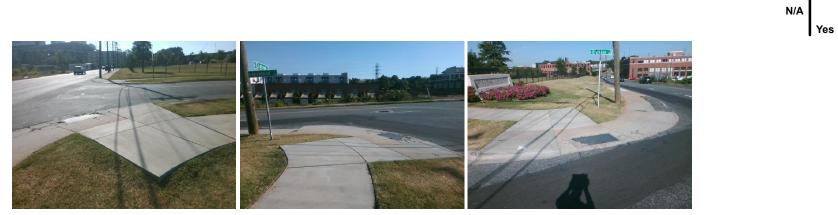
C. C.				N/A	Flare Traversable LT?	N/A	N/A	Flare Traversable RT?	N/A
				N/A	Landing Length (in)	N/A	N/A	DWS Provided?	N/A
		Surveyor Notes:		N/A	Landing Width (in)	N/A	N/A	DWS Contrast?	N/A
		N/A		N/A	Landing Slope (%)	N/A	N/A	DWS Length (in)	N/A
				N/A	Landing X Slope (%)	N/A	N/A	DWS Full Width?	N/A
13	G. A.			N/A	Landing Curb? (Y/N)	N/A	N/A	DWS Offset (in)	N/A
				N/A	Shared Landing?	N/A			
		PROW/ADA:		N/A	Gutter Ponding?	N/A	N/A	Gutter Slope (%)	N/A
		Not Found, R304.5.3		N/A	Gutter Lip Ht (in)	N/A	N/A	Gutter X Slope (%)	N/A
				N/A	Painted X Walk1?	No	N/A	Painted X Walk2?	No
					X Walk 1 Direction	To SE		X Walk 2 Direction	To NE
				N/A	X Walk 1 Width (in)	N/A	N/A	X Walk 2 Width (in)	N/A
Street 1 Name	S CLARKSON ST				X Walk 1 Slope (%)	6.8		X Walk 2 Slope (%)	2.8
Stop Condition-Street 2	StopSign				X Walk 1 X Slope (%)	3.8		X Walk 2 X Slope (%)	7.5
Street 2 Name	W MOREHEAD ST			N/A	Ramp inside XWalk1?	N/A	N/A	Ramp inside XWalk2?	N/A

Stop Condition-Street 1	None				Road Slope (%)	0.7	N/A	Clear Space?	N/A
					Road X Slope (%)	6.5	N/A	Clear Space to XWalk (in)	N/A
				N/A	Any Obstructions?	N/A	N/A	Storm Grate/Utility Hazard?	N/A
		Total Cost: \$ 3	200.00		Obstruction Type			Storm Grate/Utility Type	
						N/A			N/A
