Access Compliance Report Public Rights-of-Way (Curb Ramps)

Intersection ID: 53493 Main Street: PROVIDENCE_COUNTRY_CLUBE_ross Street: MCGILL_HEIGHTS_RD Location: SE

Overall Compliance: No ADA ID: FE75BE1A096E Ramp Type: Perp Initial Pass/Fail: Fail **Severity Score:** 12.5

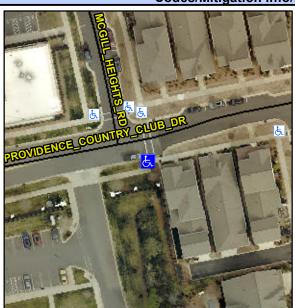
/Possible Solution		Field Measurements/Component Compliance					
Possible Solutions:		Comp	liance Description	Data	Compli	ance Description	Data
Remove & Replace Entire Ra	amp.	N/A	Ramp Length (in)	67.0	Yes	Ramp Slope (%)	6.8

-	Yes	Ramp Width (in)	79.0	No	Ramp XSlope (%)	5.8
		N/A	Flare Type LT	N/A	N/A	Flare Type RT	N/A
		N/A	Flare Slope LT (%)	N/A	N/A	Flare Slope RT (%)	N/A
1		N/A	Flare Traversable LT?	N/A	N/A	Flare Traversable RT?	N/A
		N/A	Landing Length (in)	N/A	N/A	DWS Provided?	N/A
Surveyor Notes:		N/A	Landing Width (in)	N/A	N/A	DWS Contrast?	N/A
N/A		N/A	Landing Slope (%)	N/A	N/A	DWS Length (in)	N/A
		N/A	Landing X Slope (%)	N/A	N/A	DWS Full Width?	N/A
		N/A	Landing Curb? (Y/N)	N/A	N/A	DWS Offset (in)	N/A
		N/A	Shared Landing?	N/A			
PROW/ADA:		N/A	Gutter Ponding?	N/A	N/A	Gutter Slope (%)	N/A
R304.5.3		N/A	Gutter Lip Ht (in)	N/A	N/A	Gutter X Slope (%)	N/A
		N/A	Painted X Walk1?	No	N/A	Painted X Walk2?	N/A
			X Walk 1 Direction	To N		X Walk 2 Direction	N/A
		N/A	X Walk 1 Width (in)	N/A	N/A	X Walk 2 Width (in)	N/A
			X Walk 1 Slope (%)	1.5		X Walk 2 Slope (%)	N/A
			X Walk 1 X Slope (%)	1.5		X Walk 2 X Slope (%)	N/A
		N/A	Ramp inside XWalk1?	N/A	N/A	Ramp inside XWalk2?	N/A

Road Slope (%)	N/A	N/A	Clear Space?	N/A
			Road X Slope (%)	N/A	N/A	Clear Space to XWalk (in)	N/A
		N/A	Any Obstructions?	N/A	N/A	Storm Grate/Utility Hazard?	N/A
Total Cost: \$	1850.00		Obstruction Type			Storm Grate/Utility Type	
				N/A			N/A
					Yes	Surface Condition? (G/P)	Good
