## Access Compliance Report Public Rights-of-Way (Curb Ramps)

Intersection ID: 19678 Main Street: S. TRVON ST				Cross Street, OLDE WHITEHALL BD				NW
Intersection ID: 19678			Cross Street: OLDE_WHITEHALL_RD			Location:		
ADA ID: FE93A7BA0E41	ID: FE93A7BA0E41 Ramp Type: Perp		Initial Pass/Fail: Fail Overall Compliance: No			o Severity Score:	12.5	
Codes/Mitigation Info/Possible Solution			Field Measurements/Component Compliance

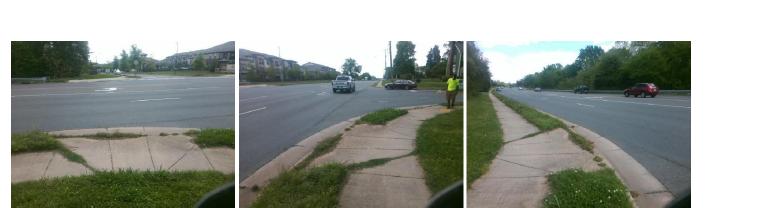
- Trees	1125	Possible Solutions:	Compliance Description Data			Compliance Description		Data
		Remove & Replace Entire Ramp.	N/A	Ramp Length (in)	84.0	No	Ramp Slope (%)	8.4
			Yes	Ramp Width (in)	48.0	Yes	Ramp XSlope (%)	0.3
			N/A	Flare Type LT	N/A	N/A	Flare Type RT	N/A
	1 Contraction		N/A	Flare Slope LT (%)	N/A	N/A	Flare Slope RT (%)	N/A
			N/A	Flare Traversable LT?	N/A	N/A	Flare Traversable RT?	N/A
			N/A	Landing Length (in)	N/A	N/A	DWS Provided?	N/A
		Surveyor Notes:	N/A	Landing Width (in)	N/A	N/A	DWS Contrast?	N/A
	E CARACTER ST	N/A	N/A	Landing Slope (%)	N/A	N/A	DWS Length (in)	N/A
	and the second		N/A	Landing X Slope (%)	N/A	N/A	DWS Full Width?	N/A
OLDE WHITEHALL RD	5.		N/A	Landing Curb? (Y/N)	N/A	N/A	DWS Offset (in)	N/A
A A A A A A A A A A A A A A A A A A A	CORMIVELL LIN		N/A	Shared Landing?	N/A			
T		PROW/ADA:	N/A	Gutter Ponding?	N/A	N/A	Gutter Slope (%)	N/A
