# Access Compliance Report

## Public Rights-of-Way (Curb Ramps)

Intersection ID: 3750	Main Street: DEER_CROSS_TL	Cross Street: HERITAGE_WOODS_PL	Location: SW
ADA ID: FE9A24F42A18	Ramp Type: Directional1	Initial Pass/Fail: Fail	Overall Compliance: No
			Severity Score: 21.25

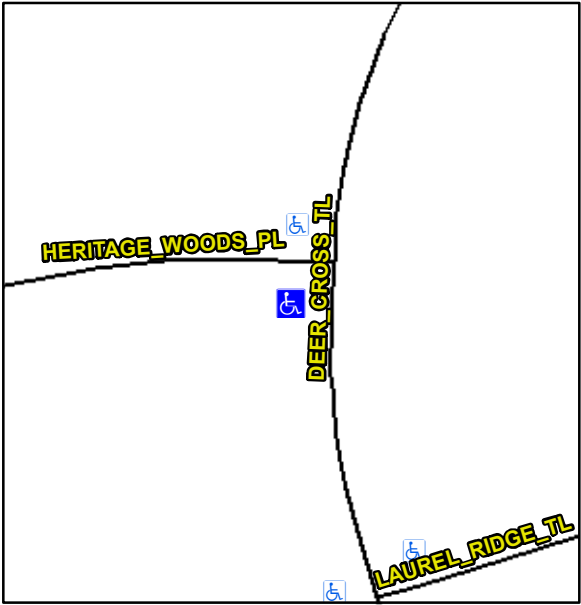
Possible Solutions:		<b>Compliance</b>	<b>Description</b>	<b>Data</b>
	Remove & Replace Entire Ramp.		N/A	Ramp Length (in)	32.0
			No	Ramp Width (in)	40.0
			No	Ramp Slope (%)	9.7
			Yes	Ramp XSlope (%)	0.9
			N/A	Flare Type LT	N/A
			N/A	Flare Slope LT (%)	N/A
			N/A	Flare Traversable LT?	N/A
			N/A	Flare Type RT	N/A
			N/A	Flare Slope RT (%)	0.0
<p>Surveyor Notes:</p> <p>N/A</p>			N/A	Grade Break?	N/A
			N/A	Grade Break Slope (%)	0.0
			N/A	Grade Break XSlope (%)	0.0
			N/A	Flare Type RT	N/A
			N/A	Flare Slope RT (%)	0.0
			N/A	Flare Traversable RT?	N/A
			N/A	DWS Provided?	N/A
			N/A	DWS Contrast?	N/A
			N/A	DWS Length (in)	N/A
			N/A	DWS Full Width?	N/A
<p>PROW/ADA:</p> <p>R304.5.1, R304.2.2</p>			N/A	DWS Offset LT (in)	N/A
			N/A	DWS Offset RT (in)	N/A
			N/A	Gutter Slope (%)	N/A
			N/A	Gutter Lip Ht (in)	N/A
			N/A	Gutter X Slope (%)	N/A

N/A	Road Slope (%)	1.3
			N/A	Road X Slope (%)	4.0
			N/A	Clear Space?	N/A
			N/A	Clear Space to XWalk (in)	N/A
			N/A	Storm Grate/Utility Hazard?	N/A
<p>Total Cost:</p> <p>\$ 1600.00</p>			N/A	Storm Grate/Utility Type	N/A
			N/A	Obstruction Type	N/A
			Yes	Surface Condition? (G/P)	Good
			N/A	Curb Slope (%)	12.6
