## **Access Compliance Report Public Rights-of-Way** (Curb Ramps)

Intersection ID: 21114 Main Street: BENT BRANCH RD Cross Street: CARMEL\_RD Location: NE **Overall Compliance: No** Severity Score: 13.75 **ADA ID: FEAA1F7F4339** Ramp Type: Directional1 Initial Pass/Fail: Fail

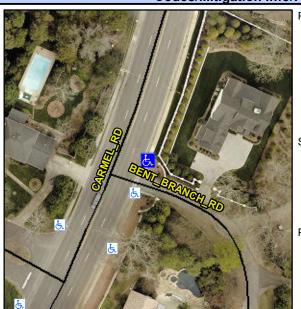
Field Measurements/Component Compliance						
Compliance Description		Data	Comp	liance Description	Dat	
N/A	Ramp Length (in)	79.0	N/A	Grade Break?	N/A	
Yes	Ramp Width (in)	51.0	N/A	Grade Break Slope (%)	0.	
No	Ramp Slope (%)	11.9	N/A	Grade Break XSlope (%)	0.	
Yes	Ramp XSlope (%)	4.0				
N/A	Flare Type LT	N/A	N/A	Flare Type RT	N/A	
N/A	Flare Slope LT (%)	N/A	N/A	Flare Slope RT (%)	0.	
N/A	Flare Traversable LT?	N/A	N/A	Flare Traversable RT?	N/A	
N/A	Landing Length (in)	0.0	N/A	DWS Provided?	N/A	
N/A	Landing Width (in)	0.0	N/A	DWS Contrast?	N/A	
N/A	Landing Slope (%)	0.0	N/A	DWS Length (in)	N/A	
N/A	Landing X Slope (%)	0.0	N/A	DWS Full Width?	N/A	
N/A	Landing Curb? (Y/N)	N/A	N/A	DWS Offset LT (in)	N/A	
N/A	Shared Landing?	N/A	N/A	DWS Offset RT (in)	N/A	
N/A	Gutter Ponding?	0.0	N/A	Gutter Slope (%)	N/A	
N/A	Gutter Lip Ht (in)	0.0	N/A	Gutter X Slope (%)	N/A	
N/A	Painted X Walk1?	No		Road Slope (%)	0.	
	X Walk 1 Direction	To SW		Road X Slope (%)	9.

X Walk 1 Width (in)	N/A		Clear Space?	N/A	
	X Walk 1 Slope (%)	0.6	N/A	Clear Space to XWalk (in)	N/A	
	X Walk 1 X Slope (%)	9.5	N/A	Storm Grate/Utility Hazard?	N/A	
N/A	Ramp inside XWalk1?	N/A		Storm Grate/Utility Type		
N/A	Any Obstructions?	N/A			N/A	
	Obstruction Type		Yes	Surface Condition? (G/P)	Goo	
		N/A	N/A	Curb Slope (%)	13.

Possible Solutions:					
Remove & Replace Entire Ramp.					
Cumping Nation					
Surveyor Notes:					
N/A					
PROW/ADA:					
R304.2.2
