Access Compliance Report

Public Rights-of-Way

(Curb Ramps)

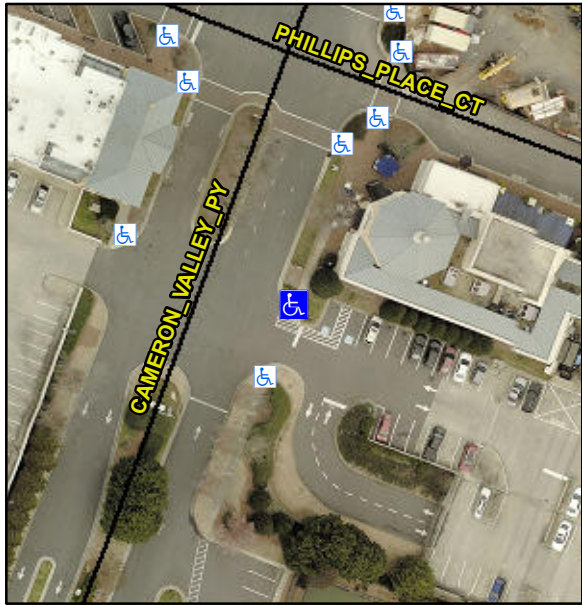
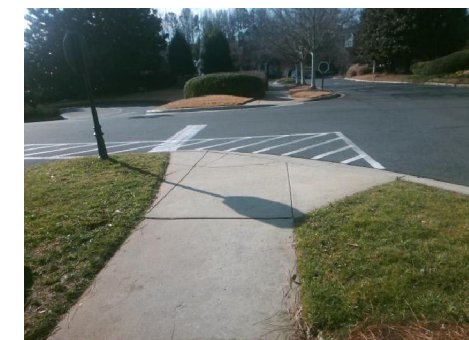
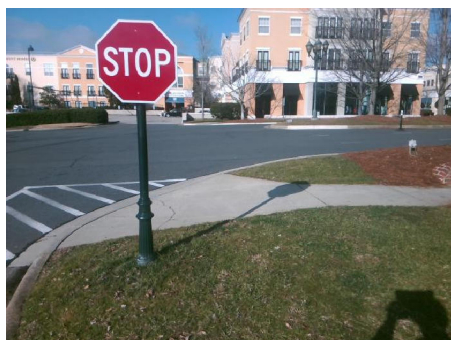
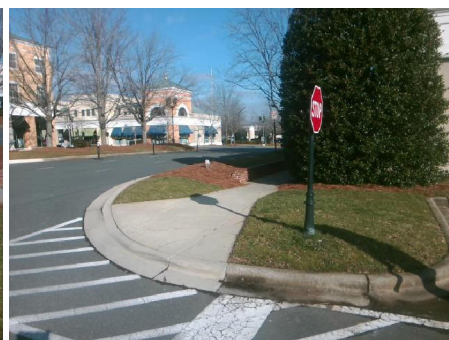
Intersection ID: N/A		Main Street: COMERON_VALLEY_PY		Cross Street: N/A		Location: NE			
ADA ID: FEABBFDFD4E7		Ramp Type: Directional1		Initial Pass/Fail: Fail		Overall Compliance: No		Severity Score: 12.5	
Codes/Mitigation Info/Possible Solution				Field Measurements/Component Compliance					
<div>

</div> <div>Street 1 NameENTRANCE</div> <div>Stop Condition-Street 1StopSign</div> <div>Street 2 NameN/A</div> <div>Stop Condition-Street 2N/A</div> <div>Possible Solutions: Remove & Replace Entire Ramp.</div> <div>Surveyor Notes: N/A</div> <div>PROW/ADA: R304.2.2</div> <div>Total Cost: \$ 1600.00</div>				Compliance	Description	Data	Compliance	Description	Data
				N/A	Ramp Length (in)	100.0	N/A	Grade Break?	N/A
				Yes	Ramp Width (in)	59.5	N/A	Grade Break Slope (%)	0.0
				No	Ramp Slope (%)	9.5	N/A	Grade Break XSlope (%)	0.0
				Yes	Ramp XSlope (%)	1.9			
				N/A	Flare Type LT	N/A	N/A	Flare Type RT	N/A

N/A	Flare Slope LT (%)	N/A	N/A	Flare Slope RT (%)	0.0
				N/A	Flare Traversable LT?	N/A	N/A	Flare Traversable RT?	N/A
				N/A	Landing Length (in)	0.0	N/A	DWS Provided?	N/A
				N/A	Landing Width (in)	0.0	N/A	DWS Contrast?	N/A
				N/A	Landing Slope (%)	0.0	N/A	DWS Length (in)	N/A
				N/A	Landing X Slope (%)	0.0	N/A	DWS Full Width?	N/A
				N/A	Landing Curb? (Y/N)	N/A	N/A	DWS Offset LT (in)	N/A
				N/A	Shared Landing?	N/A	N/A	DWS Offset RT (in)	N/A
				N/A	Gutter Ponding?	0.0	N/A	Gutter Slope (%)	N/A
				N/A	Gutter Lip Ht (in)	0.0	N/A	Gutter X Slope (%)	N/A
				N/A	Painted X Walk1?	No		Road Slope (%)	1.0
					X Walk 1 Direction	To S		Road X Slope (%)	3.7
					X Walk 1 Width (in)	N/A		Clear Space?	N/A
					X Walk 1 Slope (%)	1.0	N/A	Clear Space to XWalk (in)	N/A
					X Walk 1 X Slope (%)	3.7	N/A	Storm Grate/Utility Hazard?	N/A
				N/A	Ramp inside XWalk1?	N/A		Storm Grate/Utility Type	
				N/A	Any Obstructions?	N/A			N/A

Obstruction Type		Yes	Surface Condition? (G/P)	Good
							N/A	Curb Slope (%)	7.3
