Access Compliance Report Public Rights-of-Way (Curb Ramps)

Intersection ID: 24844 Main Street: CANVASBACK_DR Cross Street: CHOATE_CR Location: SW **ADA ID: FEACB637B8AB** Ramp Type: Directional1 Initial Pass/Fail: Fail **Overall Compliance: No Severity Score:** 1.25

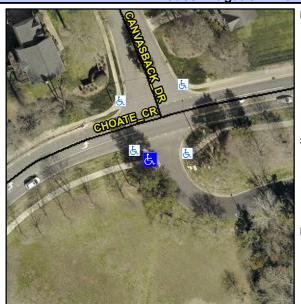
rrossible Solution			i leid measurements/component compnance						
Possible Solutions:			Compliance Description			Comp	Data		
Remove & Replace Entire	Ran	ıp.	N/A	Ramp Length (in)	80.0	N/A	Grade Break?	N/A	
·		•	Yes	Ramp Width (in)	74.0	N/A	Grade Break Slope (%)	0.0	
			Yes	Ramp Slope (%)	0.5	N/A	Grade Break XSlope (%)	0.0	
			No	Ramp XSlope (%)	2.9				
			N/A	Flare Type LT	N/A	N/A	Flare Type RT	N/A	
			N/A	Flare Slope LT (%)	N/A	N/A	Flare Slope RT (%)	0.0	
Surveyor Notes:			N/A	Flare Traversable LT?	N/A	N/A	Flare Traversable RT?	N/A	
N/A			N/A	Landing Length (in)	0.0	N/A	DWS Provided?	N/A	
			N/A	Landing Width (in)	0.0	N/A	DWS Contrast?	N/A	
			N/A	Landing Slope (%)	0.0	N/A	DWS Length (in)	N/A	
			N/A	Landing X Slope (%)	0.0	N/A	DWS Full Width?	N/A	
PROW/ADA:			N/A	Landing Curb? (Y/N)	N/A	N/A	DWS Offset LT (in)	N/A	
R304.5.3			N/A	Shared Landing?	N/A	N/A	DWS Offset RT (in)	N/A	
			N/A	Gutter Ponding?	0.0	N/A	Gutter Slope (%)	N/A

N/A	Gutter Lip Ht (in)	0.0	N/A	Gutter X Slope (%)	N/A	
			N/A	Painted X Walk1?	No		Road Slope (%)	3.8	
				X Walk 1 Direction	To NE		Road X Slope (%)	1.7	
				X Walk 1 Width (in)	N/A	l	Clear Space?	N/A	
				X Walk 1 Slope (%)	3.8	N/A	Clear Space to XWalk (in)	N/A	
				X Walk 1 X Slope (%)	1.7	N/A	Storm Grate/Utility Hazard?	N/A	
			N/A	Ramp inside XWalk1?	N/A		Storm Grate/Utility Type		
			N/A	Any Obstructions?	N/A			N/A	
Total Cost:	\$	1600.00		Obstruction Type		Yes	Surface Condition? (G/P)	Good	
					N/A	N/A	Curb Slope (%)	2.3
