Access Compliance Report

Public Rights-of-Way

(Curb Ramps)

Intersection ID: 11025	Main Street: CAMP_GREENE_ST	Cross Street: ELON_ST	Location: SW
ADA ID: FEB51A82B057	Ramp Type: Directional1	Initial Pass/Fail: Fail	Overall Compliance: No
Codes/Mitigation Info/Possible Solution		Field Measurements/Component Compliance	
Severity Score: 1.25

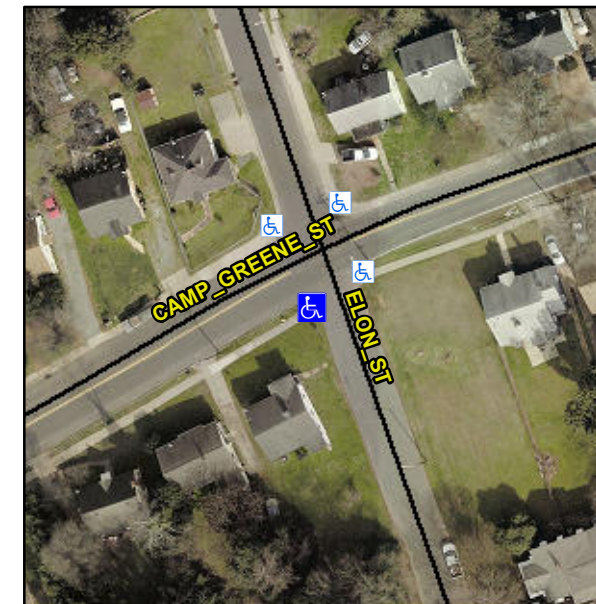
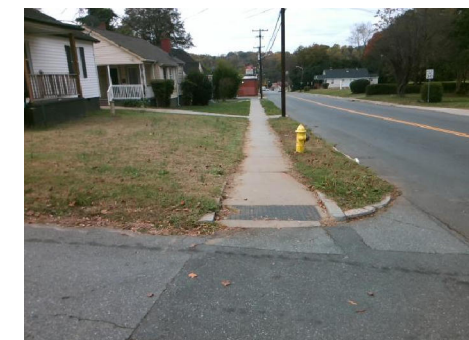
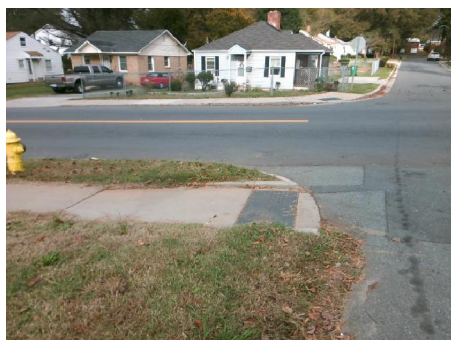
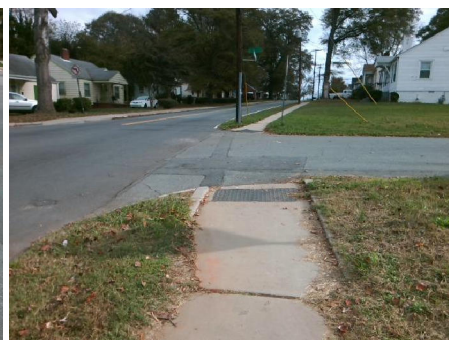
R304.5.3

Compliance	Description	Data	Compliance	Description	Data
N/A	Ramp Length (in)	118.0	N/A	Grade Break?	N/A
Yes	Ramp Width (in)	58.5	N/A	Grade Break Slope (%)	0.0
Yes	Ramp Slope (%)	8.0	N/A	Grade Break XSlope (%)	0.0
No	Ramp XSlope (%)	2.4			
N/A	Flare Type LT	N/A	N/A	Flare Type RT	N/A
N/A	Flare Slope LT (%)	N/A	N/A	Flare Slope RT (%)	0.0
N/A	Flare Traversable LT?	N/A	N/A	Flare Traversable RT?	N/A
N/A	Landing Length (in)	0.0	N/A	DWS Provided?	N/A
N/A	Landing Width (in)	0.0	N/A	DWS Contrast?	N/A
N/A	Landing Slope (%)	0.0	N/A	DWS Length (in)	N/A
N/A	Landing X Slope (%)	0.0	N/A	DWS Full Width?	N/A
N/A	Landing Curb? (Y/N)	N/A	N/A	DWS Offset LT (in)	N/A
N/A	Shared Landing?	N/A	N/A	DWS Offset RT (in)	N/A
N/A	Gutter Ponding?	0.0	N/A	Gutter Slope (%)	N/A
N/A	Gutter Lip Ht (in)	0.0	N/A	Gutter X Slope (%)	N/A
N/A	Painted X Walk1?	No		Road Slope (%)	6.5
	X Walk 1 Direction	To E		Road X Slope (%)	4.2
	X Walk 1 Width (in)	N/A		Clear Space?	N/A

X Walk 1 Slope (%)	6.5	N/A	Clear Space to XWalk (in)	N/A
	X Walk 1 X Slope (%)	4.2	N/A	Storm Grate/Utility Hazard?	N/A
N/A	Ramp inside XWalk1?	N/A		Storm Grate/Utility Type	
N/A	Any Obstructions?	N/A			N/A
	Obstruction Type		Yes	Surface Condition? (G/P)	Good
			N/A	Curb Slope (%)	0.1

Possible Solutions:

Remove & Replace Entire Ramp.

\$ 1600.00
