# Access Compliance Report

## Public Rights-of-Way

Intersection ID: 7225	Main Street: STATESVILLE_RD	Cross Street: STARITA_RD	Location: SE
ADA ID: FEB77DBBAD16	Ramp Type: Combination2	Initial Pass/Fail: Fail	Overall Compliance: No
		Severity Score: 1.25

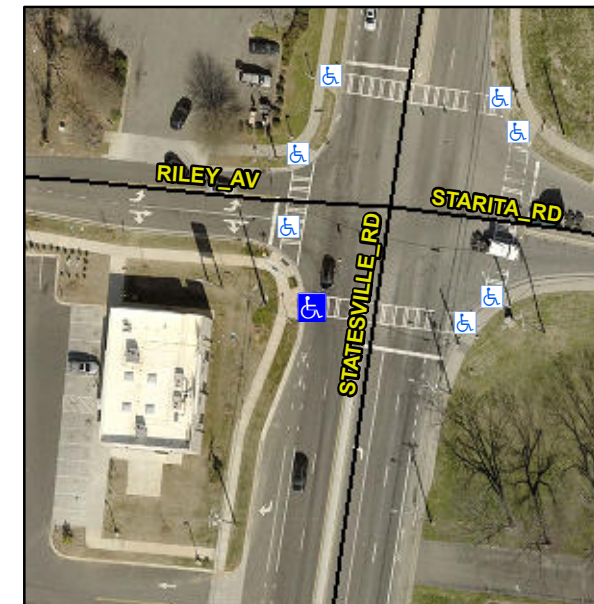
**PONDING**

**R304.5.1, R304.5.3**

Compliance	Description	Data	Compliance	Description	Data
N/A	Ramp Length LT (in)	N/A	N/A	Ramp Length RT (in)	71.0
N/A	Ramp Width LT (in)	N/A	No	Ramp Width RT (in)	34.5
N/A	Ramp Slope LT (%)	N/A	Yes	Ramp Slope RT (%)	8.1
N/A	Ramp XSlope LT (%)	N/A	No	Ramp XSlope RT (%)	4.0
N/A	Ramp Length (in)	26.0	Yes	Ramp Slope (%)	4.3
Yes	Ramp Width (in)	48.0	Yes	Ramp XSlope (%)	0.3
N/A	Flare Type LT	N/A	N/A	Flare Type RT	N/A
N/A	Flare Slope LT (%)	N/A	N/A	Flare Slope RT (%)	N/A
N/A	Flare Traversable LT?	N/A	N/A	Flare Traversable RT?	N/A
N/A	Landing Length (in)	N/A	N/A	DWS Provided?	N/A
N/A	Landing Width (in)	N/A	N/A	DWS Contrast?	N/A
N/A	Landing Slope (%)	N/A	N/A	DWS Length (in)	N/A
N/A	Landing X Slope (%)	N/A	N/A	DWS Full Width?	N/A
N/A	Landing Curb? (Y/N)	N/A	N/A	DWS Offset (in)	N/A
N/A	Shared Landing?	N/A			
N/A	Gutter Ponding?	N/A	N/A	Gutter Slope (%)	N/A
N/A	Gutter Lip Ht (in)	N/A	N/A	Gutter X Slope (%)	N/A
N/A	Painted X Walk1?	Yes	N/A	Painted X Walk2?	N/A

**Remove & Replace Entire Ramp.**

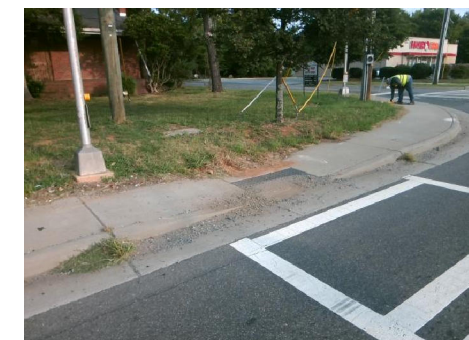
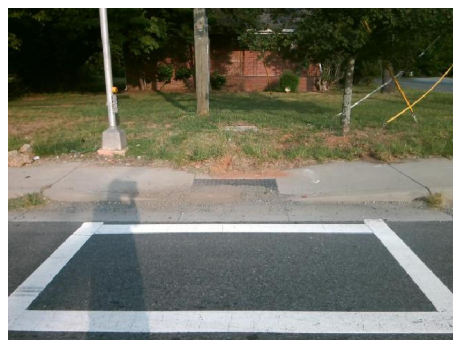
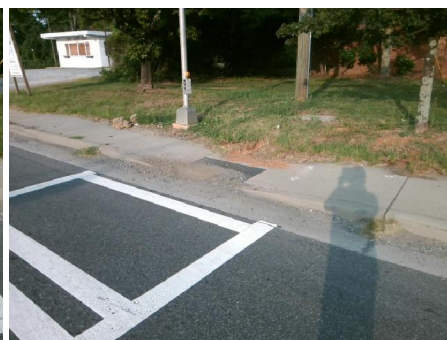
X Walk 1 Direction	To W		X Walk 2 Direction	N/A
	X Walk 1 Width (in)	111.0		X Walk 2 Width (in)	N/A
	X Walk 1 Slope (%)	1.5		X Walk 2 Slope (%)	N/A
	X Walk 1 X Slope (%)	1.1		X Walk 2 X Slope (%)	N/A
N/A	Ramp inside XWalk1?	Yes	N/A	Ramp inside XWalk2?	N/A
	Road Slope (%)	N/A		Clear Space?	N/A
	Road X Slope (%)	N/A	N/A	Clear Space to XWalk (in)	N/A
			N/A	Any Obstruction?	N/A
				Obstruction Type	N/A
			N/A	Storm Grate/Utility Hazard?	N/A
				Storm Grate/Utility Type	N/A
			Yes	Surface Condition? (G/P)	Good
				Curb Slope (%)	N/A
