Access Compliance Report Public Rights-of-Way (Curb Ramps)

Intersection ID: 8503 Main Street: TIMEPLANNER DR **Cross Street: ATANDO AV** Location: **Severity Score:** ADA ID: FEC4794D9738 Ramp Type: PerpDiag Initial Pass/Fail: Fail **Overall Compliance: No** 22.5

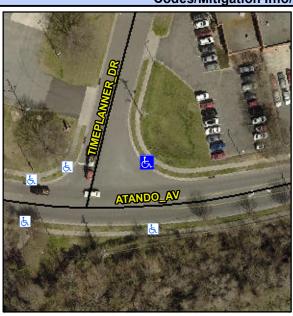
Field Measurements/Component Compliance					
Compliance Description		Data	Compliance Description		Data
N	/A Ramp Length (in)	60.0	No	Ramp Slope (%)	9.2
N	o Ramp Width (in)	43.0	No	Ramp XSlope (%)	2.1
N	A Flare Type LT	N/A	N/A	Flare Type RT	N/A
N	/A Flare Slope LT (%)	N/A	N/A	Flare Slope RT (%)	N/A
N	/A Flare Traversable LT?	N/A	N/A	Flare Traversable RT?	N/A
N	/A Landing Length (in)	N/A	N/A	DWS Provided?	N/A
N	/A Landing Width (in)	N/A	N/A	DWS Contrast?	N/A
N	/A Landing Slope (%)	N/A	N/A	DWS Length (in)	N/A
N	/A Landing X Slope (%)	N/A	N/A	DWS Full Width?	N/A
N	/A Landing Curb? (Y/N)	N/A	N/A	DWS Offset (in)	N/A

Possible Solutions: Remove & Replace Curb Ramp With Two New Directional Ramps or Equivalent. Surveyor Notes: N/A PROW/ADA: Not Found, R304.5.1, R304.2.2, R304.5.3
