Access Compliance Report

Public Rights-of-Way (Curb Ramps)

Intersection ID: 2776	Main Street: BEAUVISTA_DR	Cross Street: OAK_COVE_LN	Location: SE
ADA ID: FED9538D002C	Ramp Type: PerpDiag	Initial Pass/Fail: Fail	Overall Compliance: No
Severity Score: 46.25			
Codes/Mitigation Info/Possible Solution		Field Measurements/Component Compliance

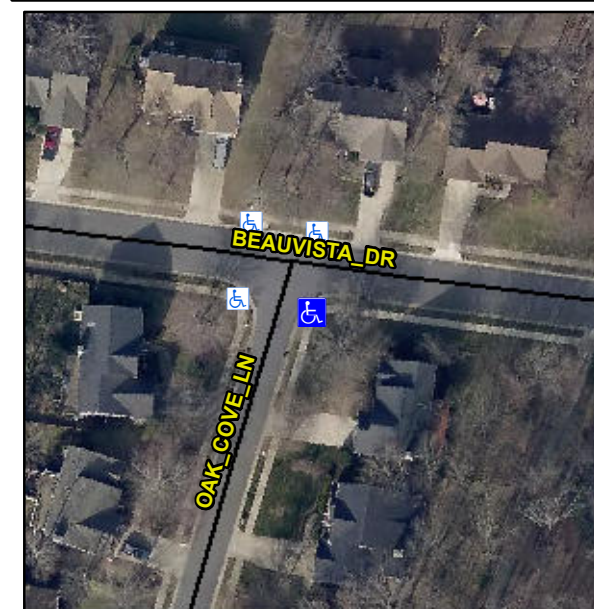
Not Found, R304.5.1, R304.2.2, R304.5.3

Compliance	Description	Data	Compliance	Description	Data
N/A	Ramp Length (in)	45.0	No	Ramp Slope (%)	12.6
No	Ramp Width (in)	43.0	No	Ramp XSlope (%)	5.1
N/A	Flare Type LT	N/A	N/A	Flare Type RT	N/A
N/A	Flare Slope LT (%)	N/A	N/A	Flare Slope RT (%)	N/A
N/A	Flare Traversable LT?	N/A	N/A	Flare Traversable RT?	N/A
N/A	Landing Length (in)	N/A	N/A	DWS Provided?	N/A
N/A	Landing Width (in)	N/A	N/A	DWS Contrast?	N/A
N/A	Landing Slope (%)	N/A	N/A	DWS Length (in)	N/A
N/A	Landing X Slope (%)	N/A	N/A	DWS Full Width?	N/A
N/A	Landing Curb? (Y/N)	N/A	N/A	DWS Offset (in)	N/A
N/A	Shared Landing?	N/A			
N/A	Gutter Ponding?	N/A	N/A	Gutter Slope (%)	N/A
N/A	Gutter Lip Ht (in)	N/A	N/A	Gutter X Slope (%)	N/A
N/A	Painted X Walk1?	No	N/A	Painted X Walk2?	No
	X Walk 1 Direction	To NE		X Walk 2 Direction	To W
N/A	X Walk 1 Width (in)	N/A	N/A	X Walk 2 Width (in)	N/A
	X Walk 1 Slope (%)	3.9		X Walk 2 Slope (%)	3.3
	X Walk 1 X Slope (%)	1.9		X Walk 2 X Slope (%)	1.5

N/A	Ramp inside XWalk1?	N/A	N/A	Ramp inside XWalk2?	N/A
	Road Slope (%)	3.7	N/A	Clear Space?	N/A
	Road X Slope (%)	4.5	N/A	Clear Space to XWalk (in)	N/A
N/A	Any Obstructions?	N/A	N/A	Storm Grate/Utility Hazard?	N/A
	Obstruction Type			Storm Grate/Utility Type	
		N/A			N/A
			Yes	Surface Condition? (G/P)	Good

Possible Solutions:

Remove & Replace Curb Ramp With Two New Directional Ramps or Equivalent.
